The Nebraska Capitol Exterior Masonry Project 1998-2010

A 1998 investigation of the entire exterior face of the Capitol revealed the weatherproof surfaces of the building were failing. The Indiana Limestone façade had deteriorated as a result of the extreme temperature fluctuations in Nebraska's climate and a problem with the original 1920's expansion joint construction had become apparent. The annual freeze thaw cycle associated with this region had cracked miles of mortar joints and allowed moisture to penetrate the walls. This moisture caused the clay brick behind the limestone to expand and shift the stone out of alignment, especially at the entrances, parapet walls and observation decks. As well, it was discovered that the original expansion joint at each floor level was not adequate; this resulted in excessive compression stress fractures in the tower's stone facade. A survey of the 2.5 acre copper roof revealed it had been installed using methods less effective than those available today resulting in chronic interior leaks. The project consulting architects and engineers developed a five-phase restoration plan which addressed these problems in the Capitol's exterior face, w

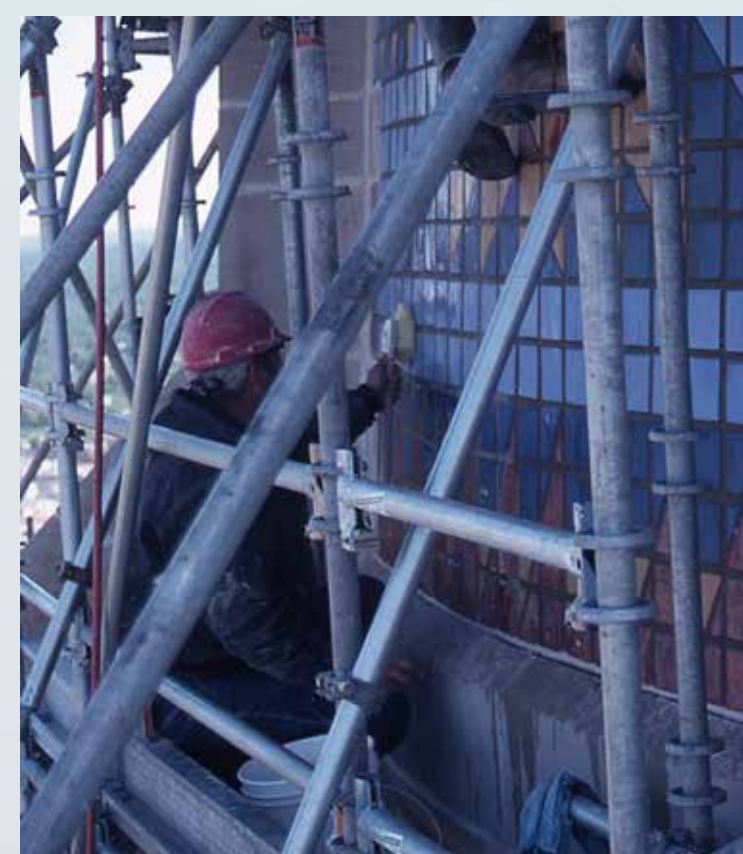
Inspection of the gold tile dome and tile Thunderbird mosaics revealed they were in good condition. Restoration involved cleaning with soapy water and adding grout where necessary. The limestone exterior was cleaned using a biocide followed by a low pressure air abrasive process.

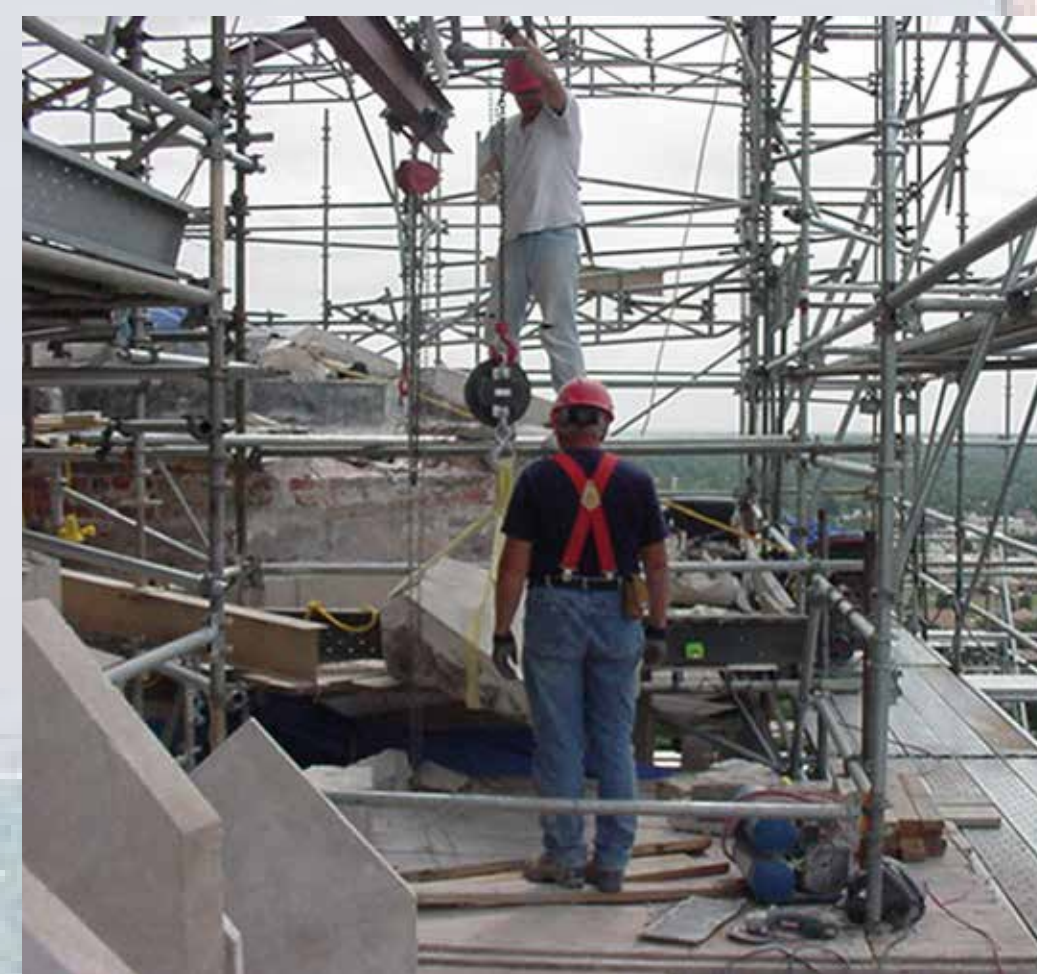
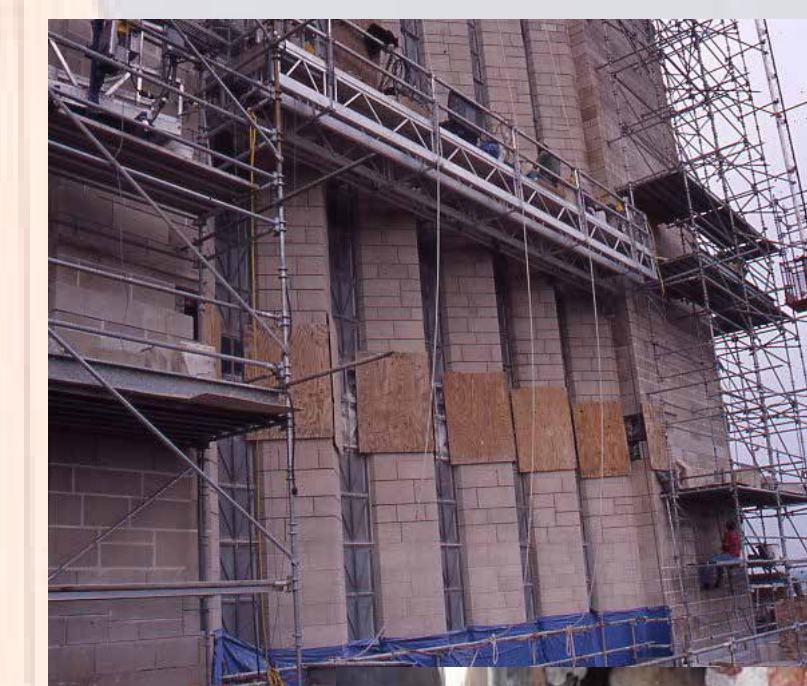
Relieving stresses in the tower required the removal of limestone veneer at each floor level. Contractors then removed the brick backing to reveal the tower's structural steel frame. Shelf supports were attached to the floor beams and the limestone veneer reapplied to rest on the supports. The added shelves transfer the weight of the limestone onto the steel frame, reducing stress on the façade and preventing further damage to the limestone.

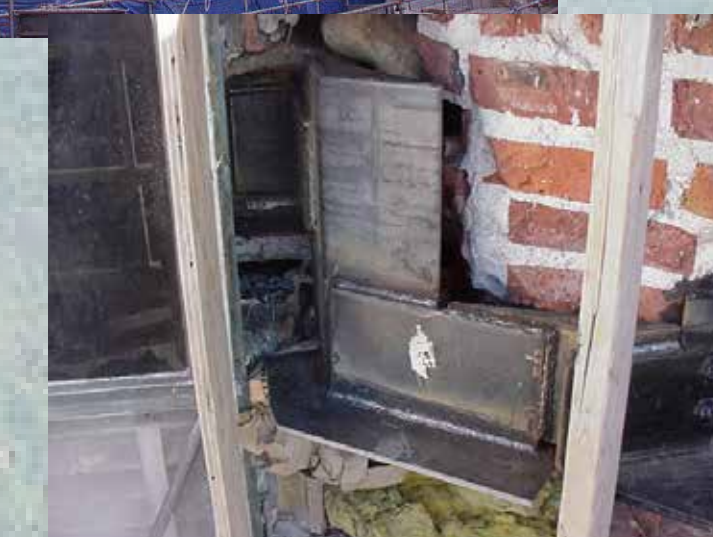
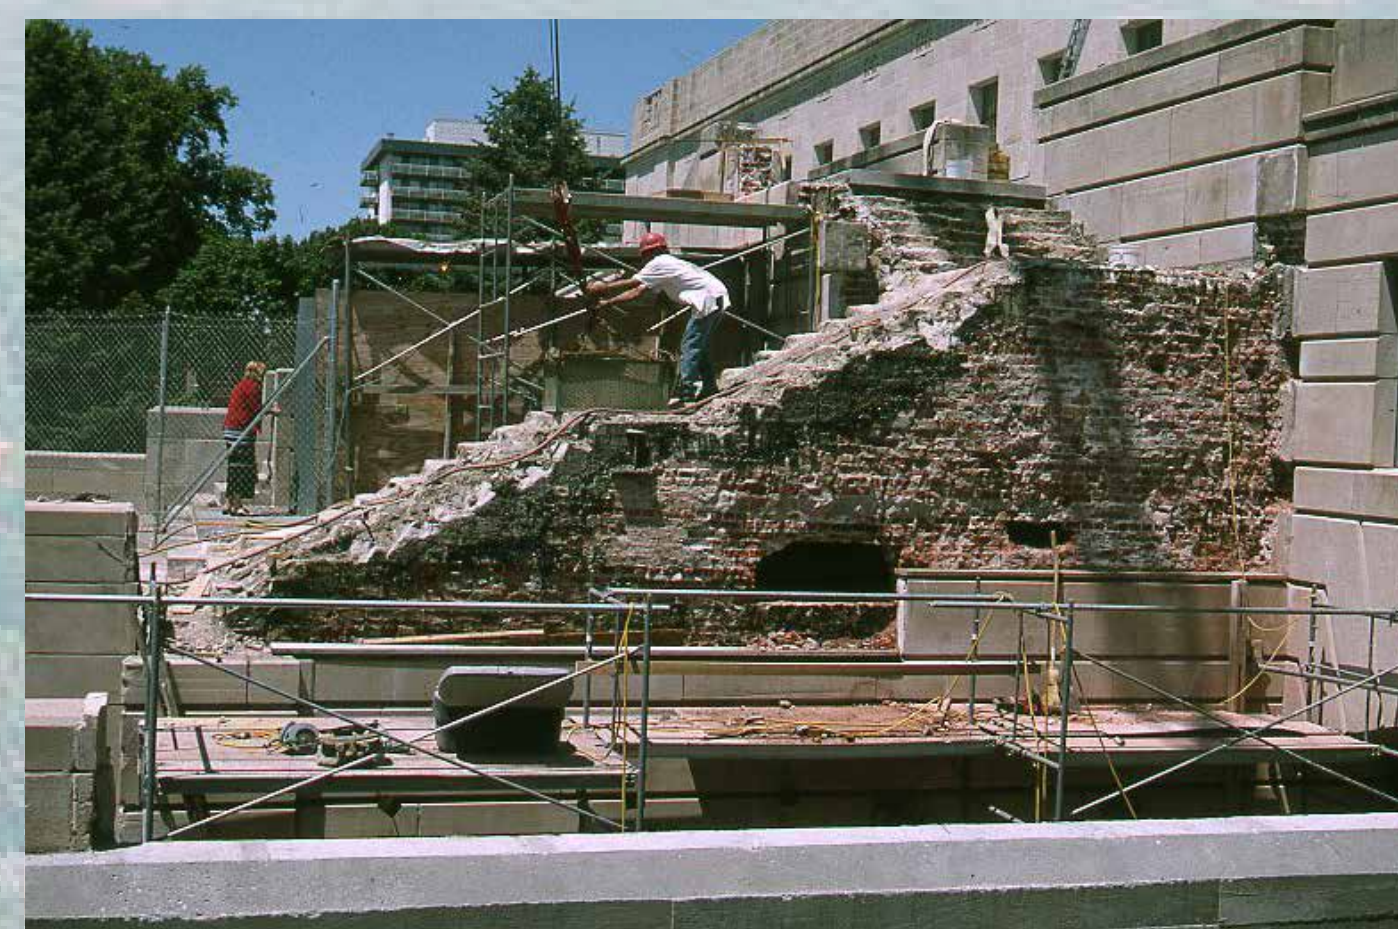
Restoration of all four entrances required removing and storing the limestone façade and granite stair treads, then demolition of the red clay brick core down to the foundation. The interior core was rebuilt using poured concrete and concrete bricks which better resist movement during freeze/thaw cycles. Added metal flashing and integrated weep holes channel water away from the interior increasing long term stability.

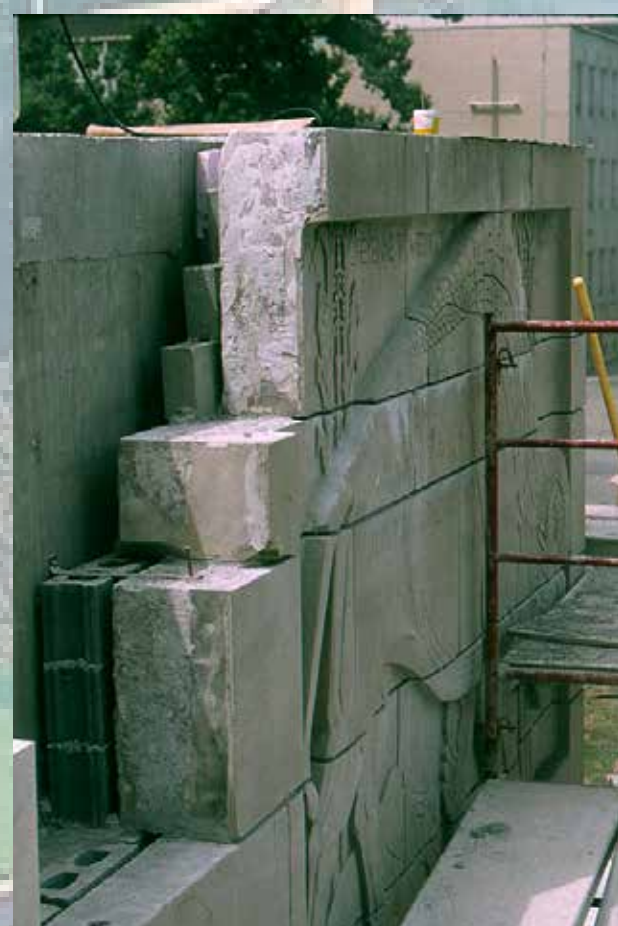
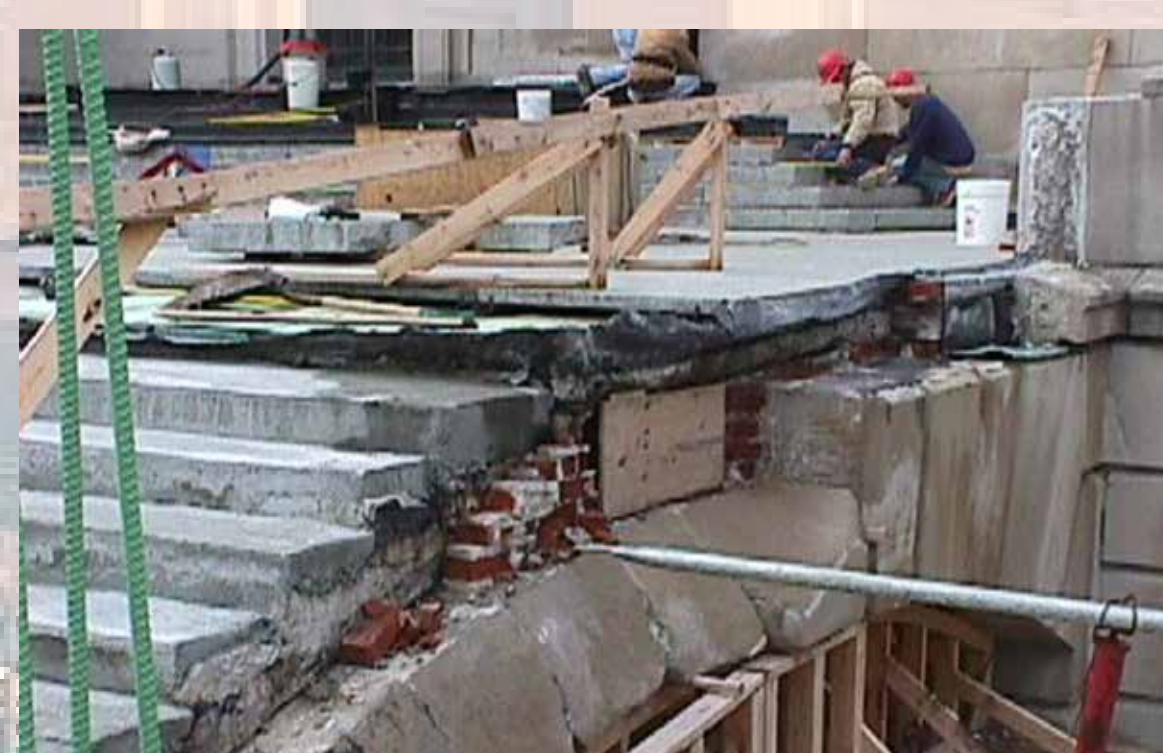
Tuck pointing is an important component of keeping the Capitol facade water tight. Contractors ground out all existing mortar and pointed over 30 miles of mortar joints.

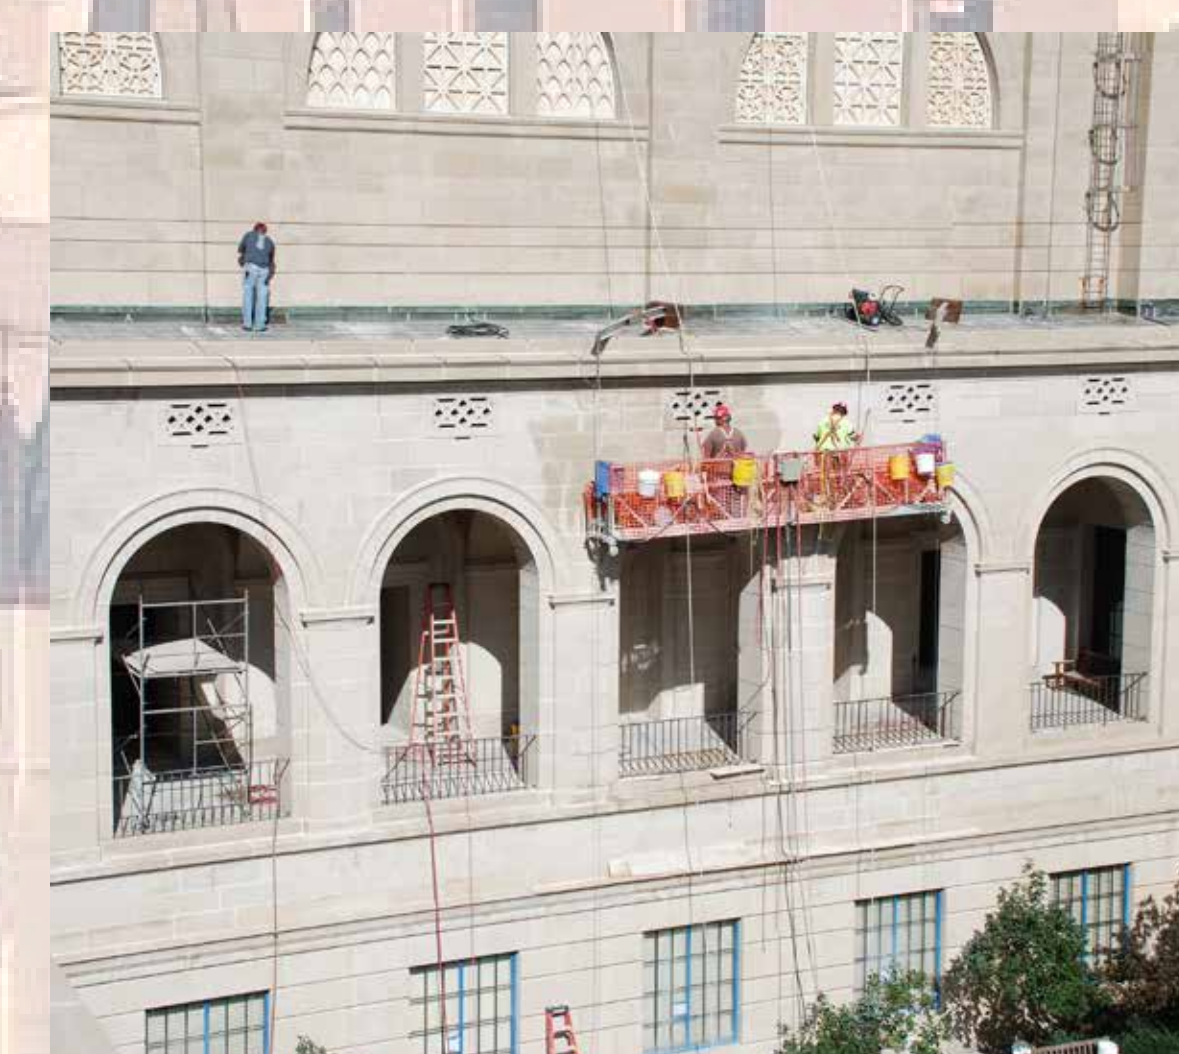
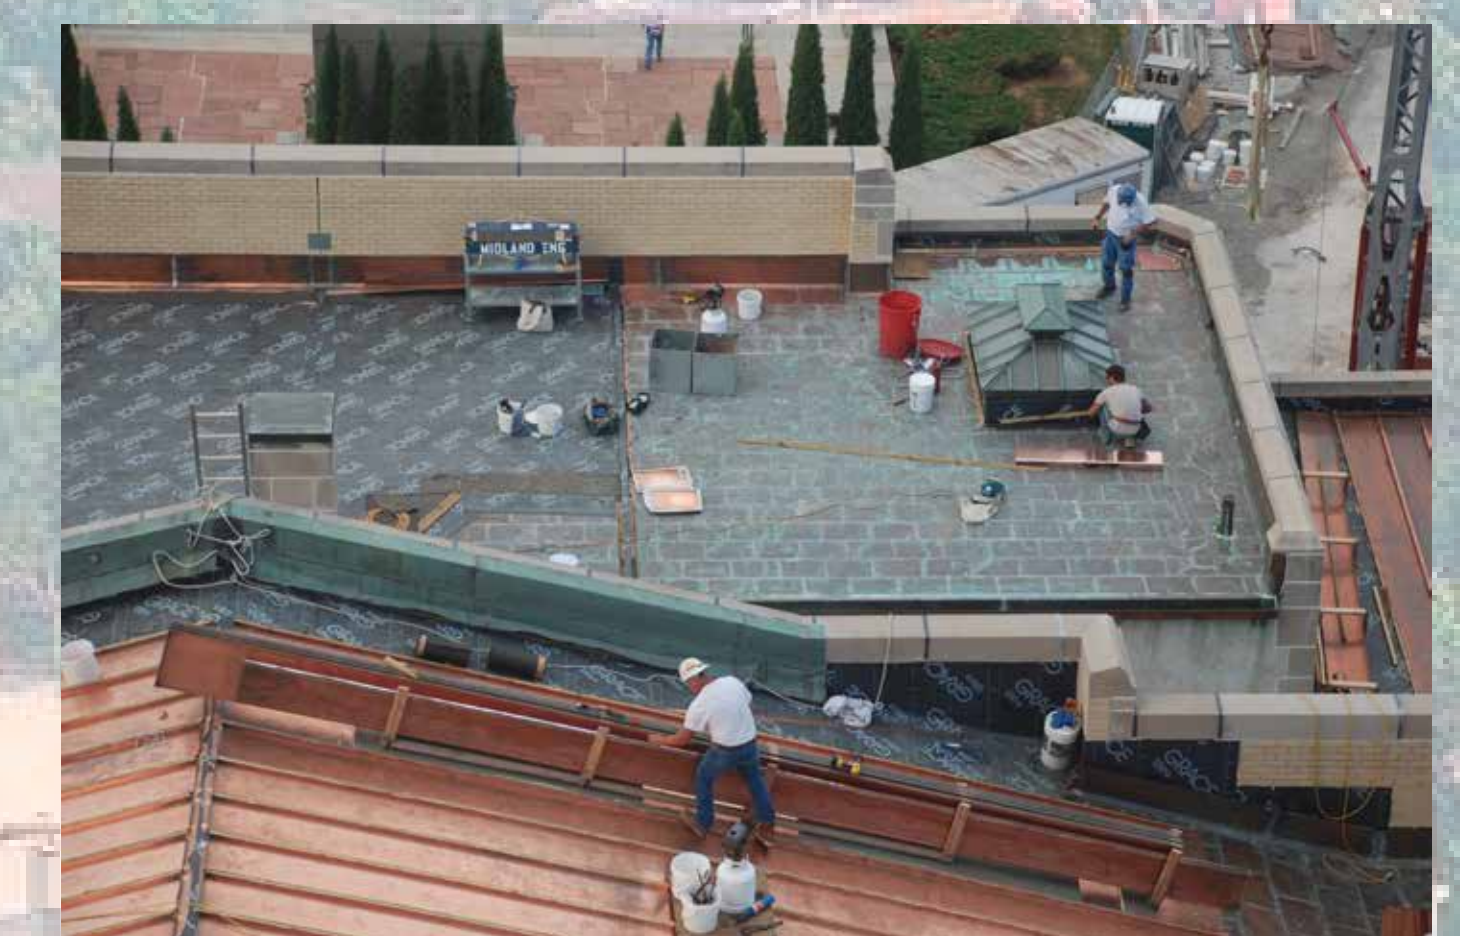
A new copper batten and flat lock roof system was applied over a waterproof membrane and insulation. Insulation was added where none existed originally. Replacing flat lock panels with a batten system decreases the number of seams reducing the potential for leaks. Wall flashing was extended to reduce ice dams causing leaks.
