KEEPING IT CLEAN -- THE NEBRASKA STATE CAPITOL

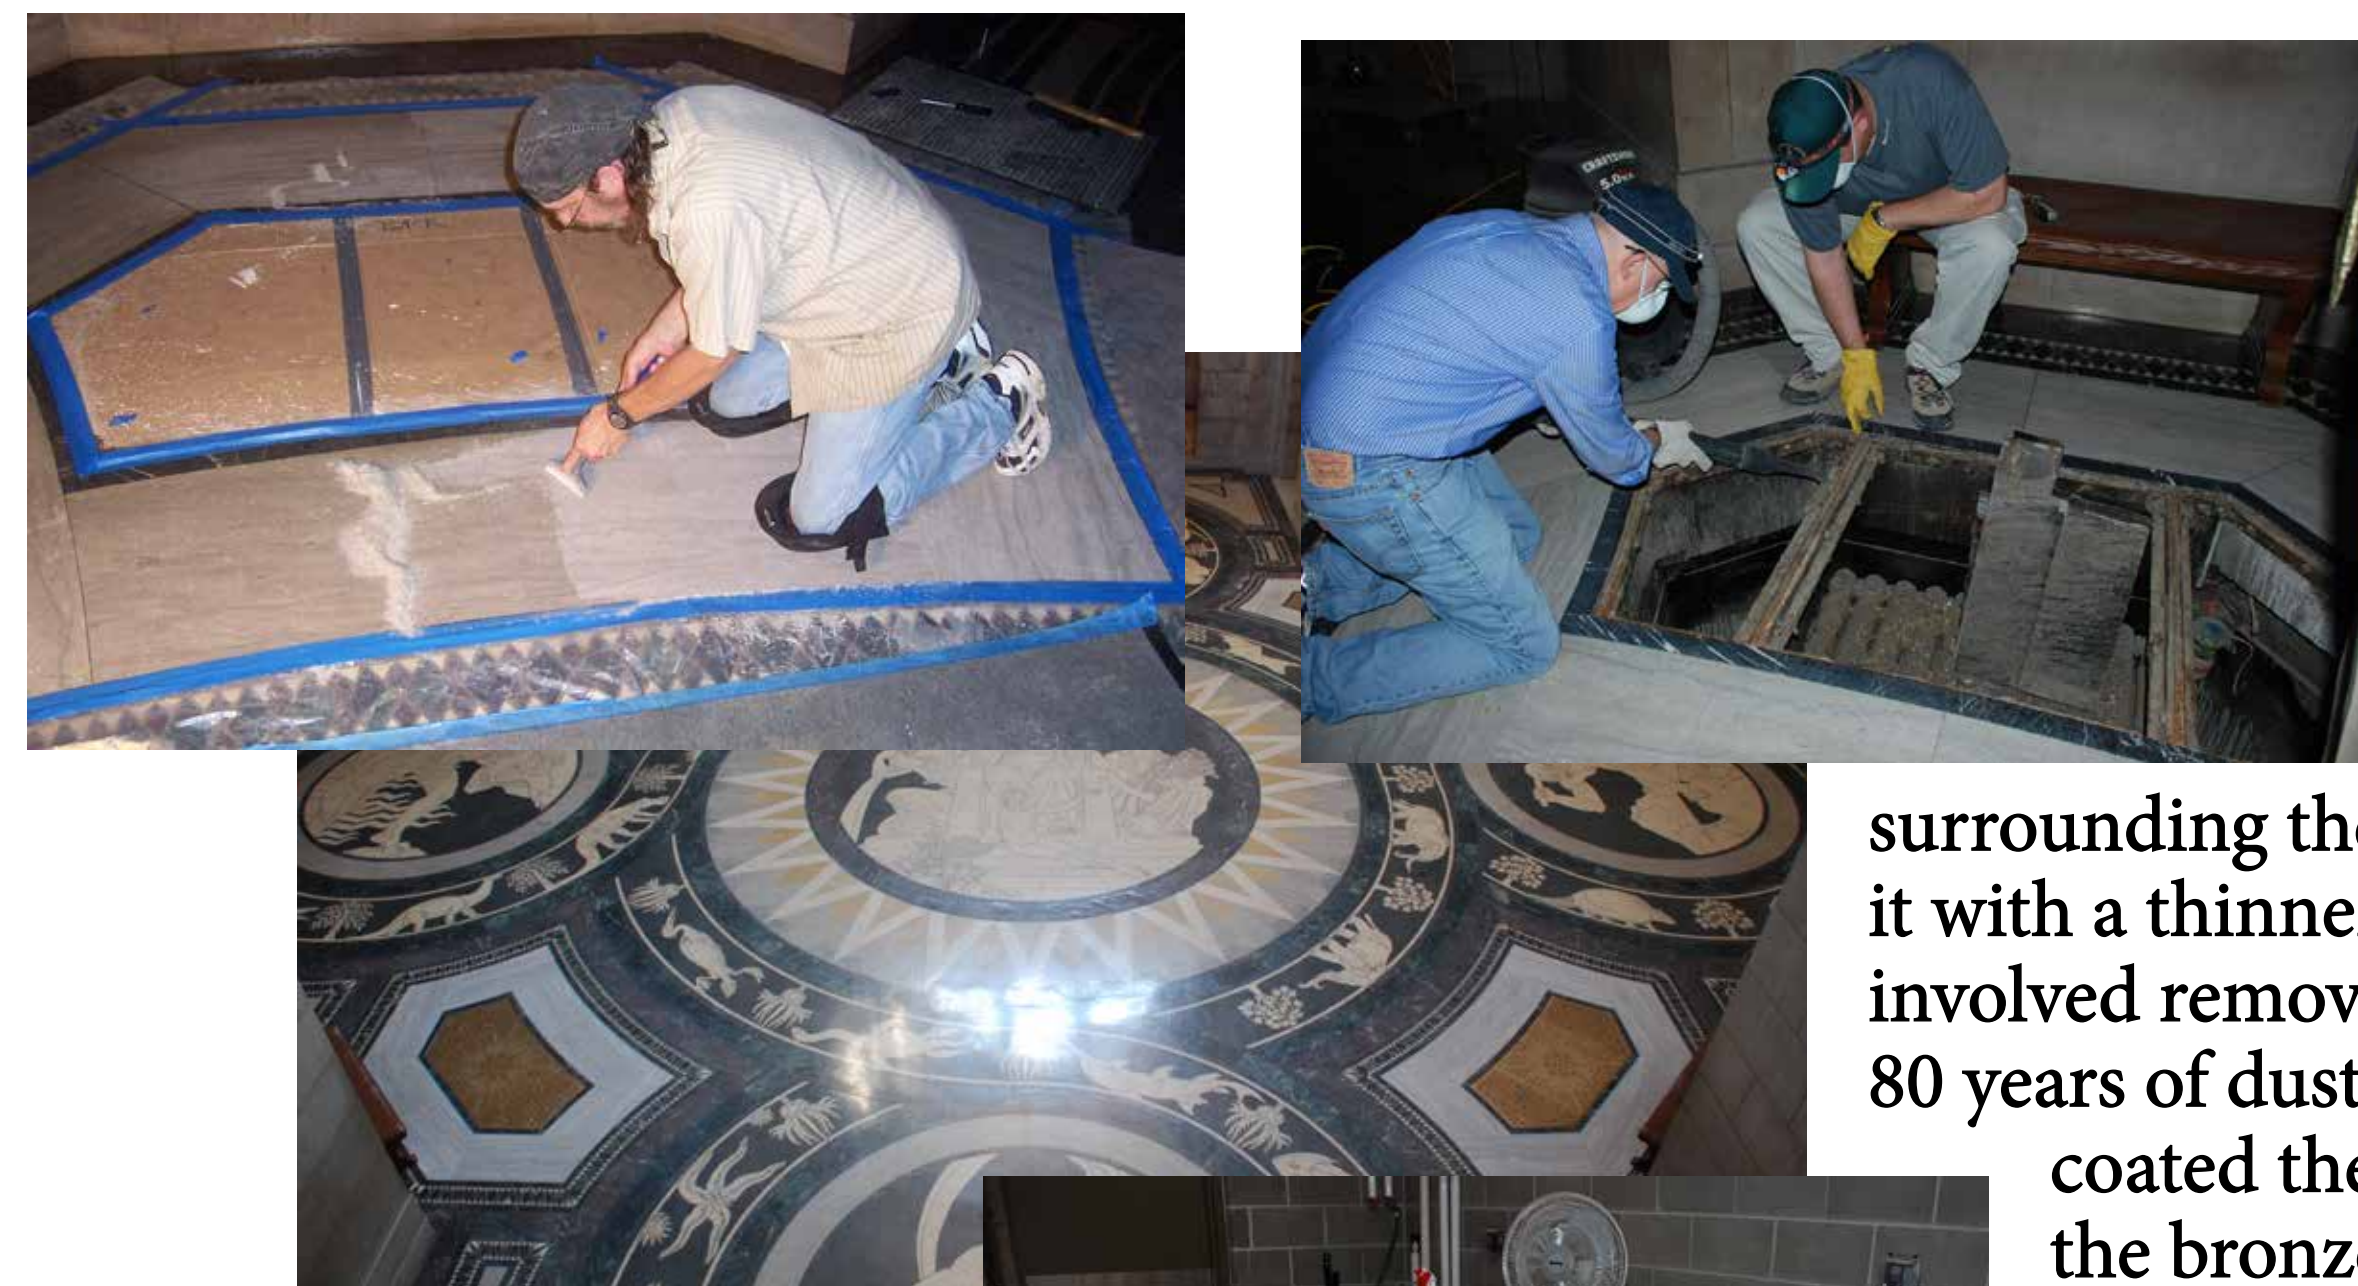
To prevent damage to Hildreth Meiere's marble mosaic floors, capitol staff began applying a wax finish in the 1980's. After 30 years the layers of wax have diminished the beauty of the mosaic floor. Capitol staff removed the heavy wax on the Napoleon Gray stone surrounding the original floor radiators and replaced it with a thinner protective layer. Additional cleaning involved removing the bronze floor grills and vacuuming 80 years of dust and grime which had fallen through and coated the radiators. Preservation staff also cleaned the bronze grills. Notice how much brighter the stone around the bronze grills appears in the central floor image.

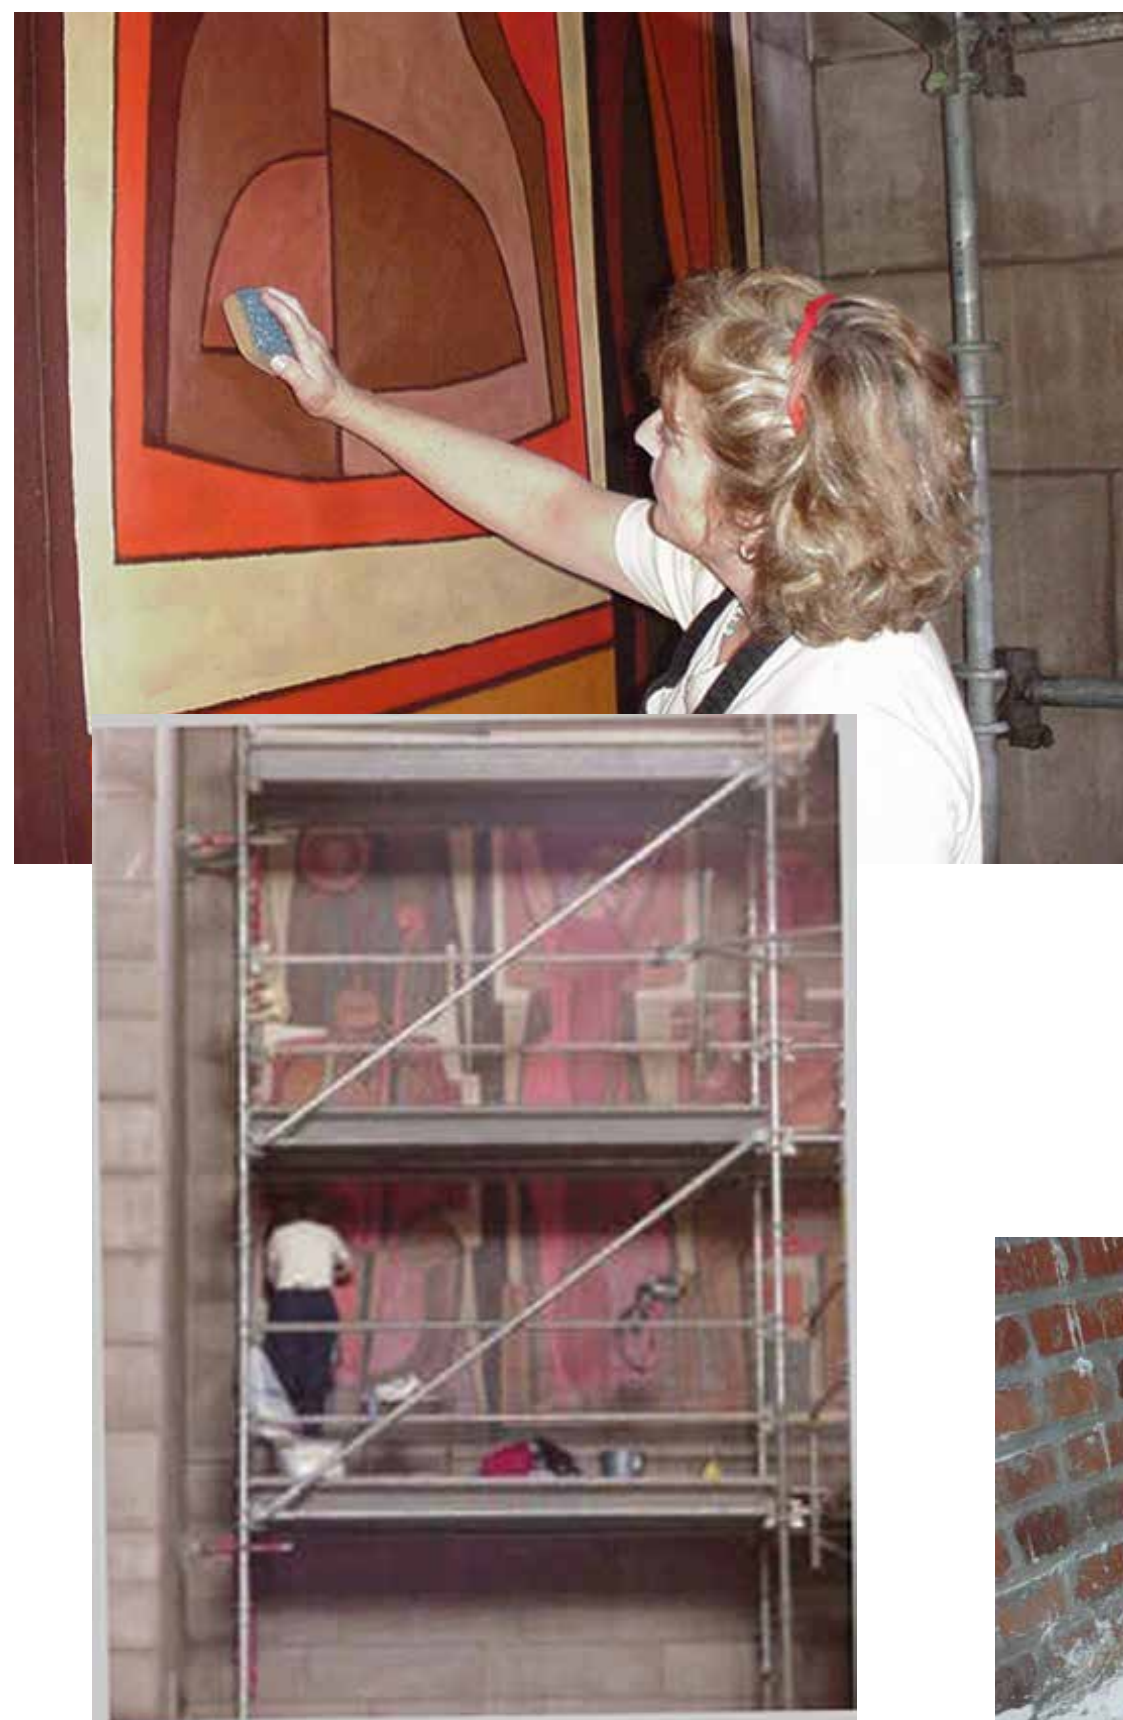
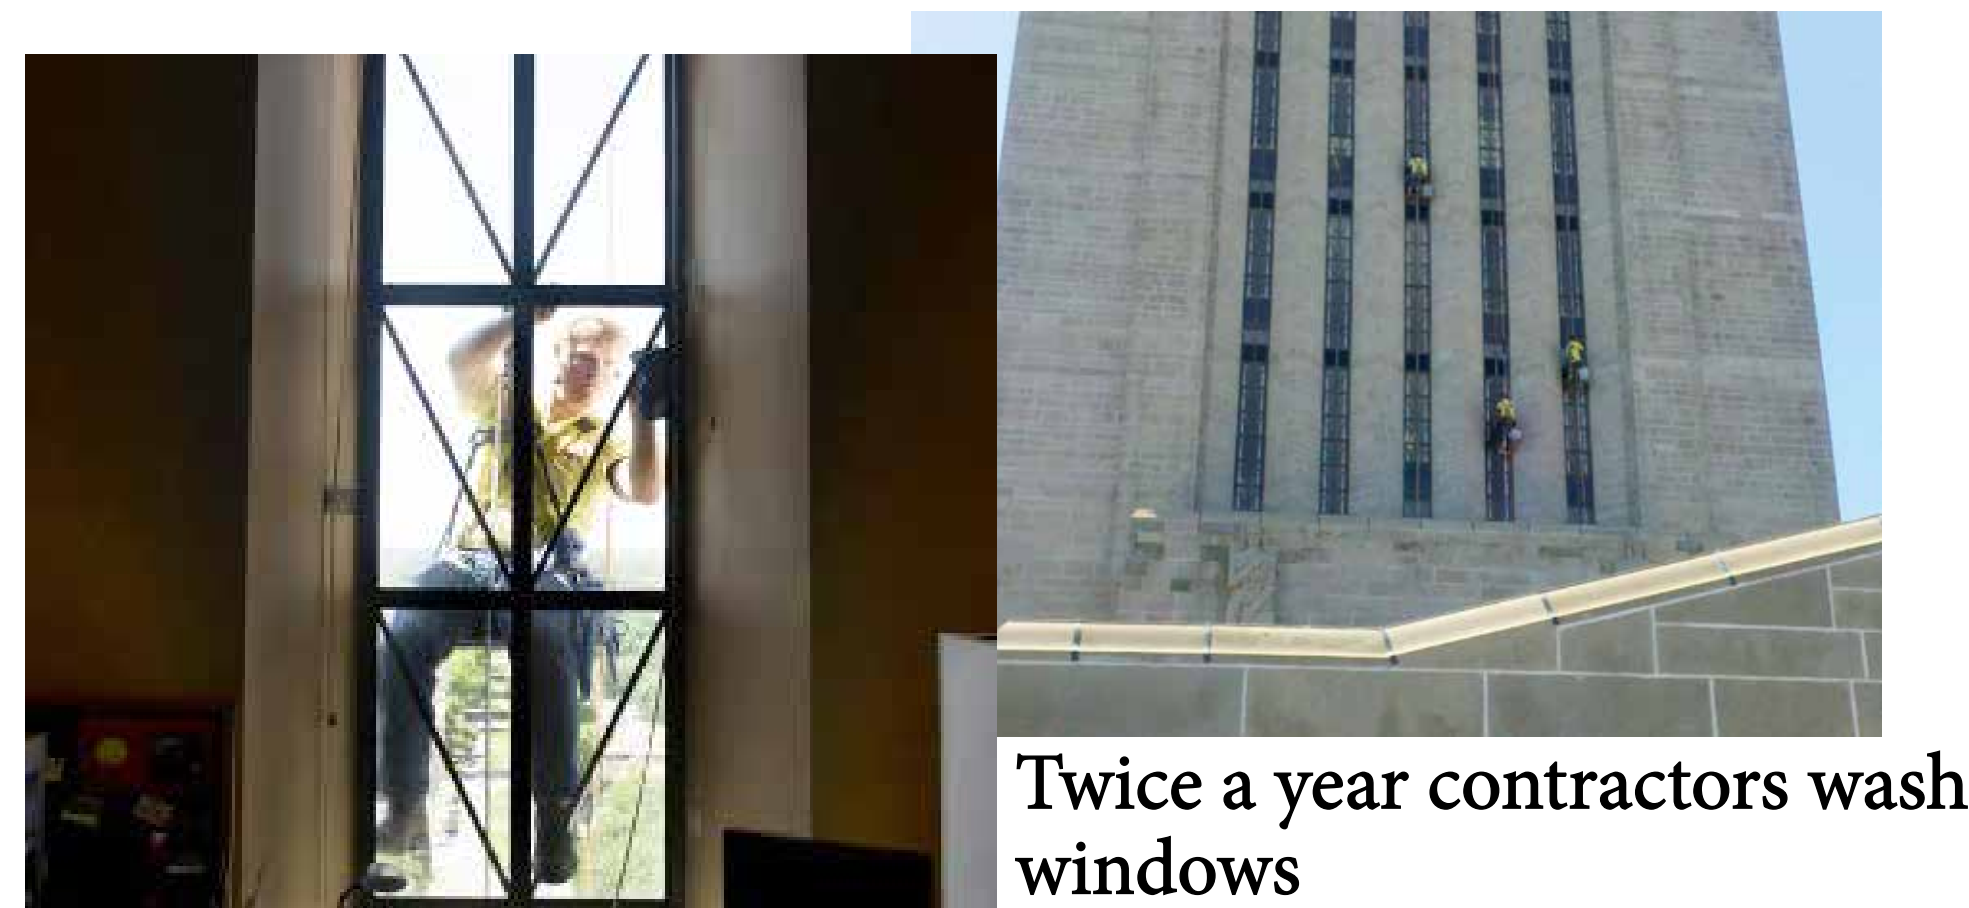
OCC calls in special conservation help to clean and restore the Capitol's many murals, preserving their beauty for future generations.

Twice a year contractors wash windows

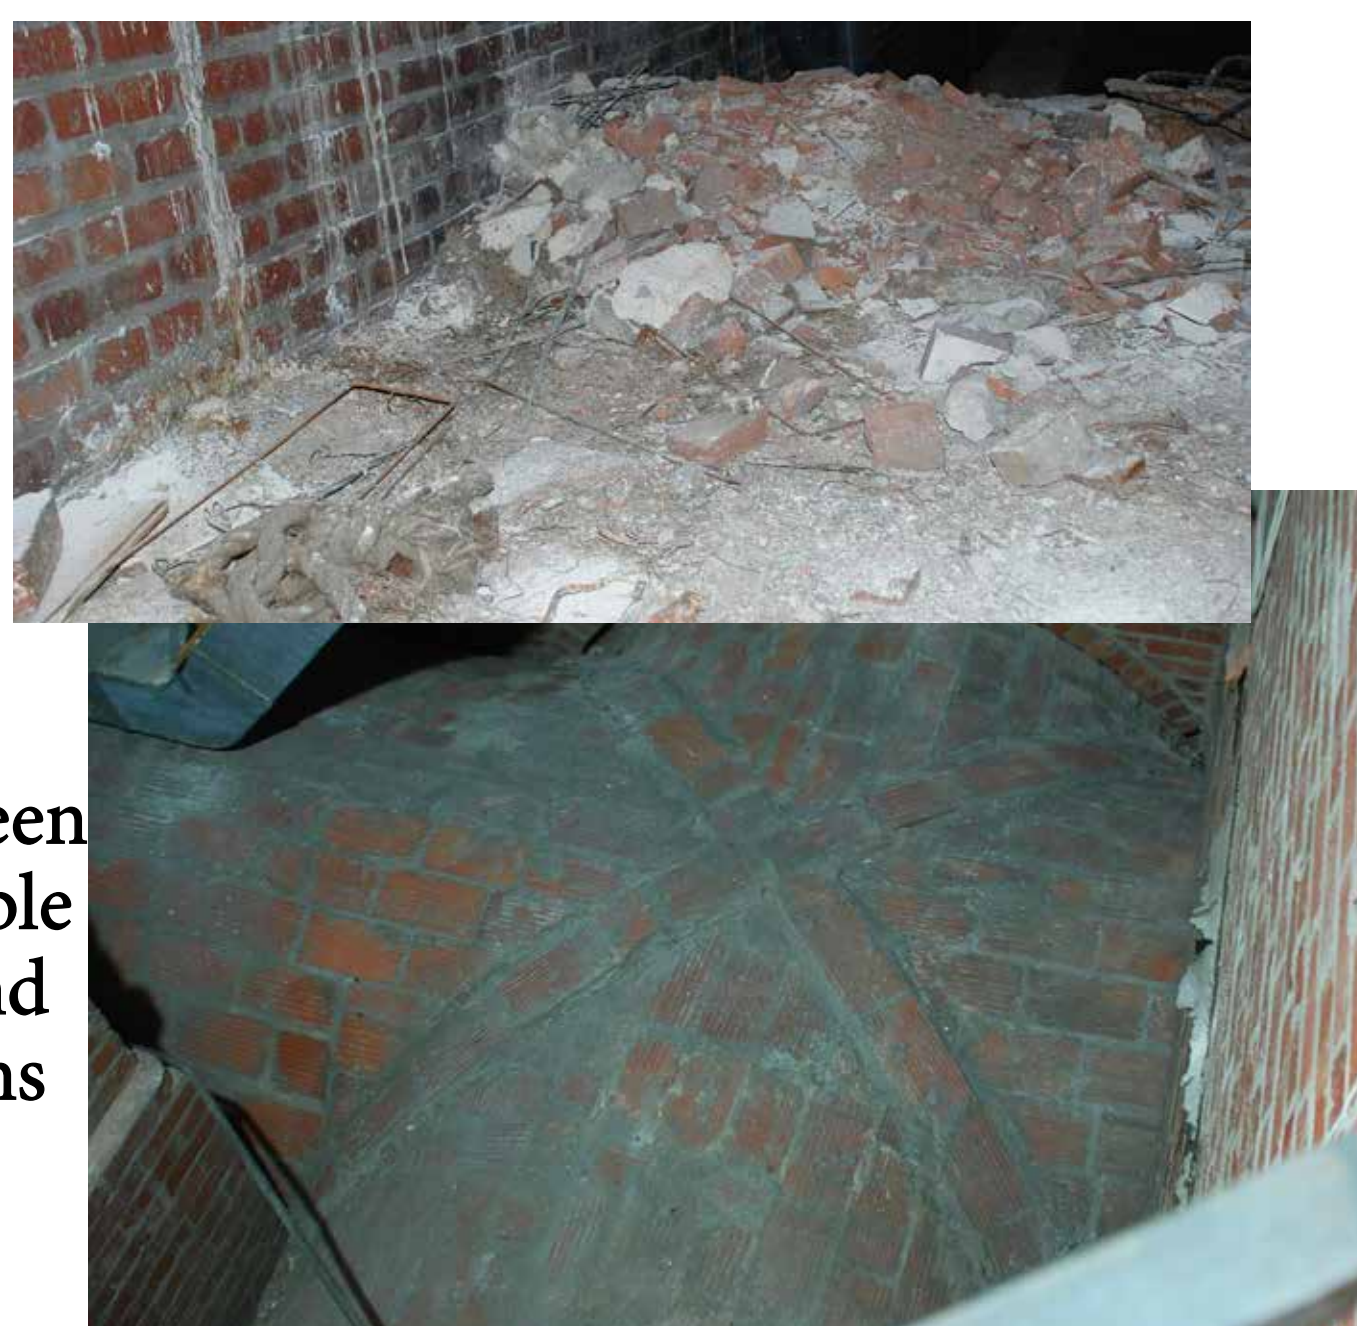
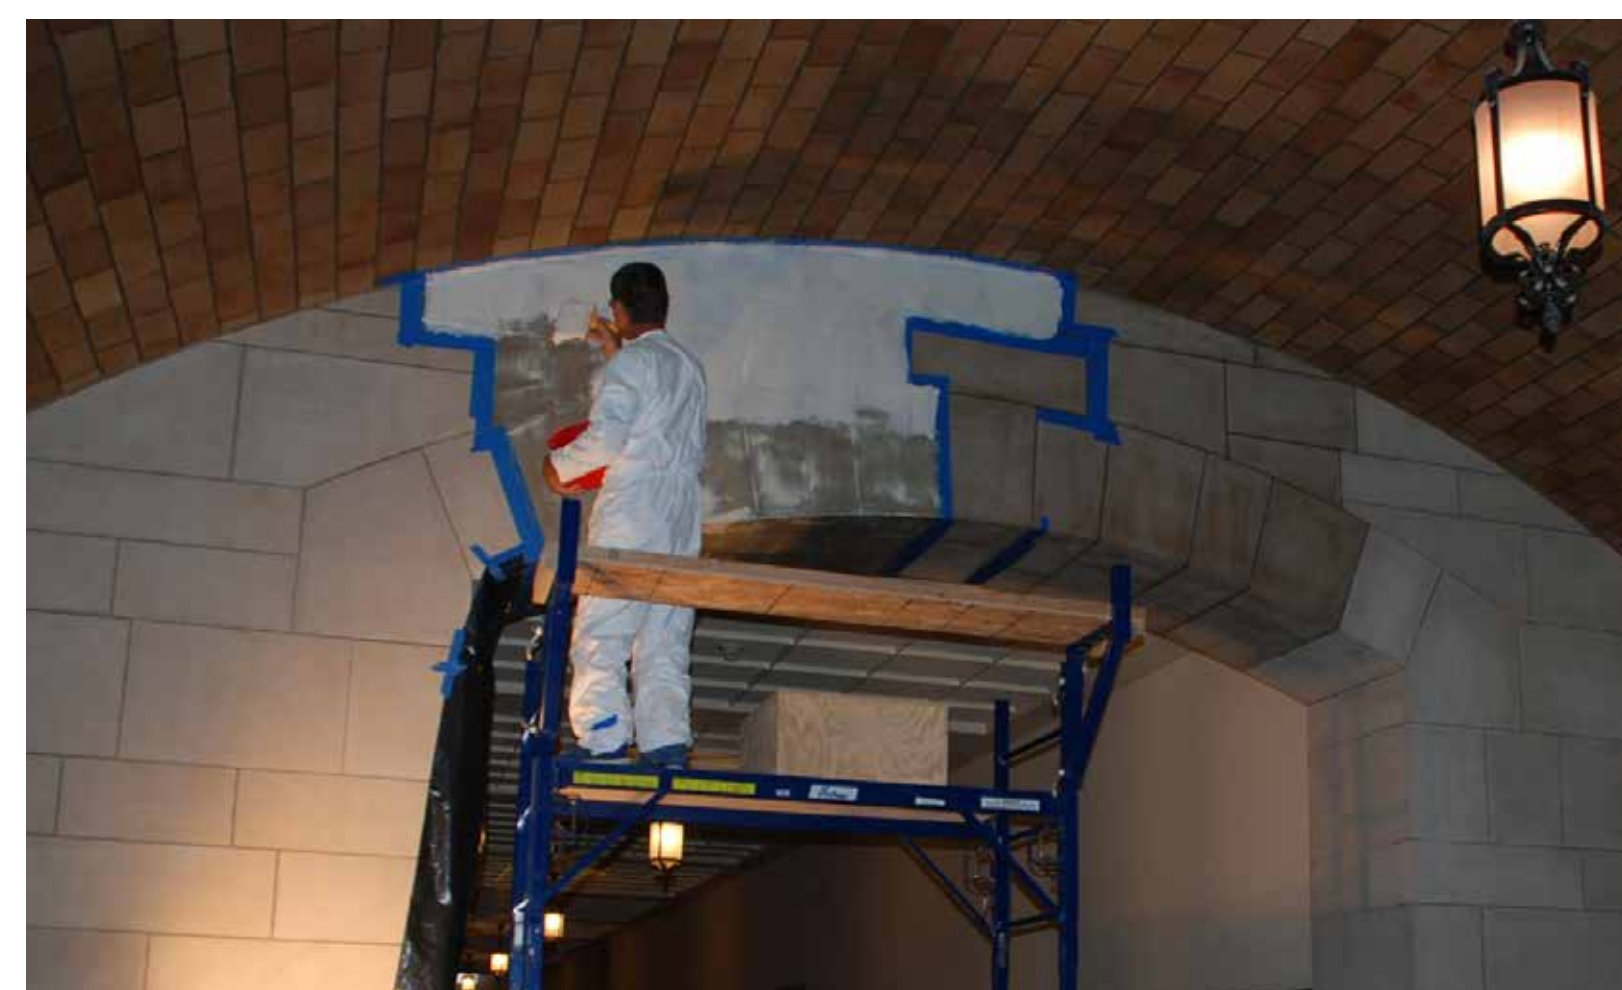
Cleaning the Indiana limestone walls with a latex poultice reveals the beauty of the stone and shows how soiled the stone has become in the 80 years since construction was completed.

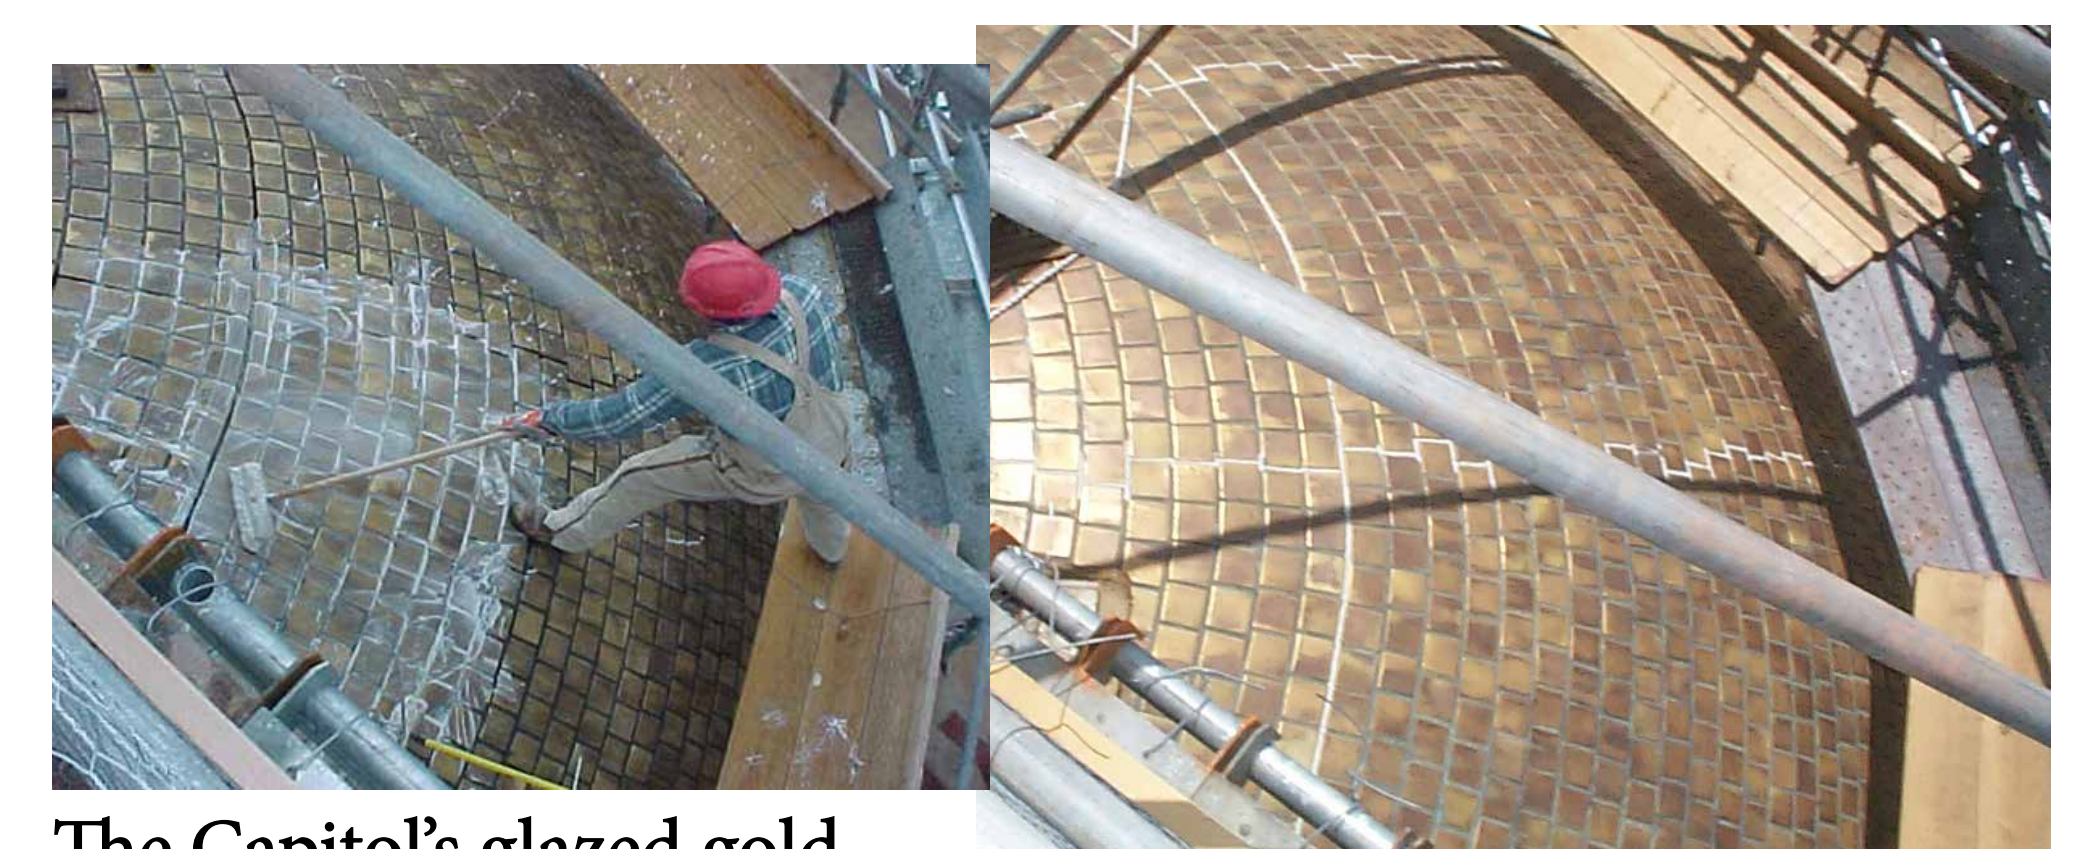
The Capitol's glazed gold tile dome 350 feet above the ground was cleaned during the 1998-2012 exterior renovation
