# 100 years ago - Walls Start to Rise

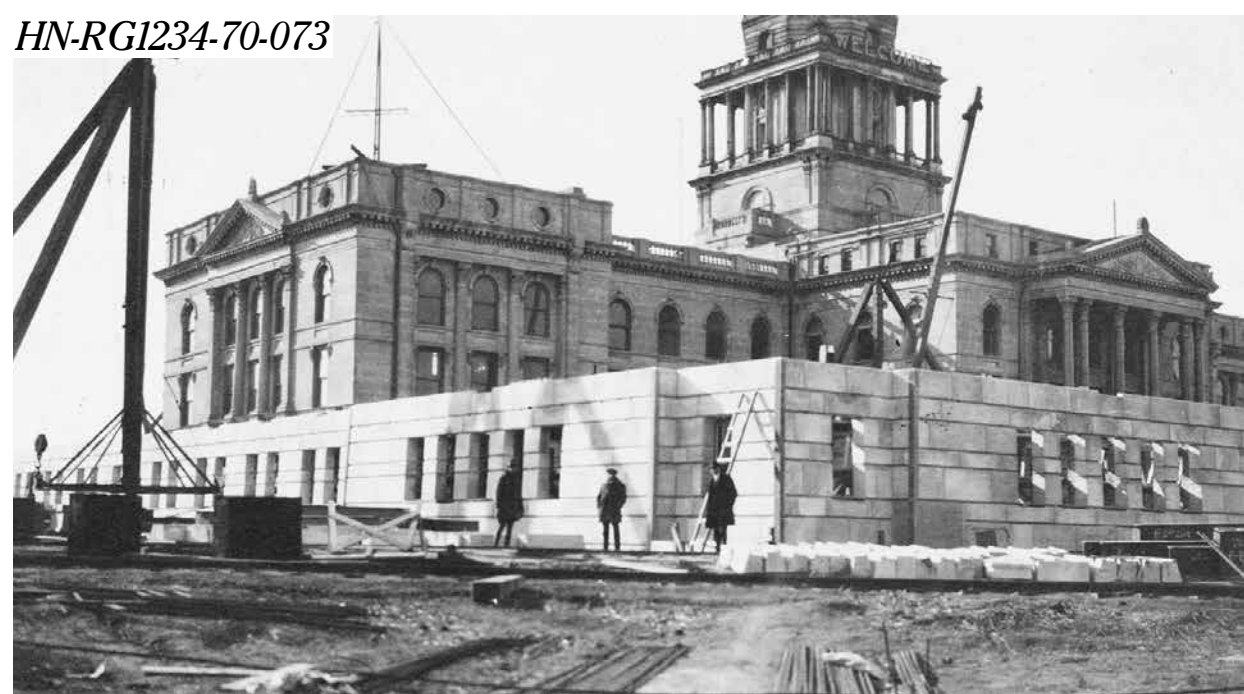
*Rising on either side of the cornerstone, the north and east first floor walls went up in November and December of 1922. This January 1923 photo shows the progress.*

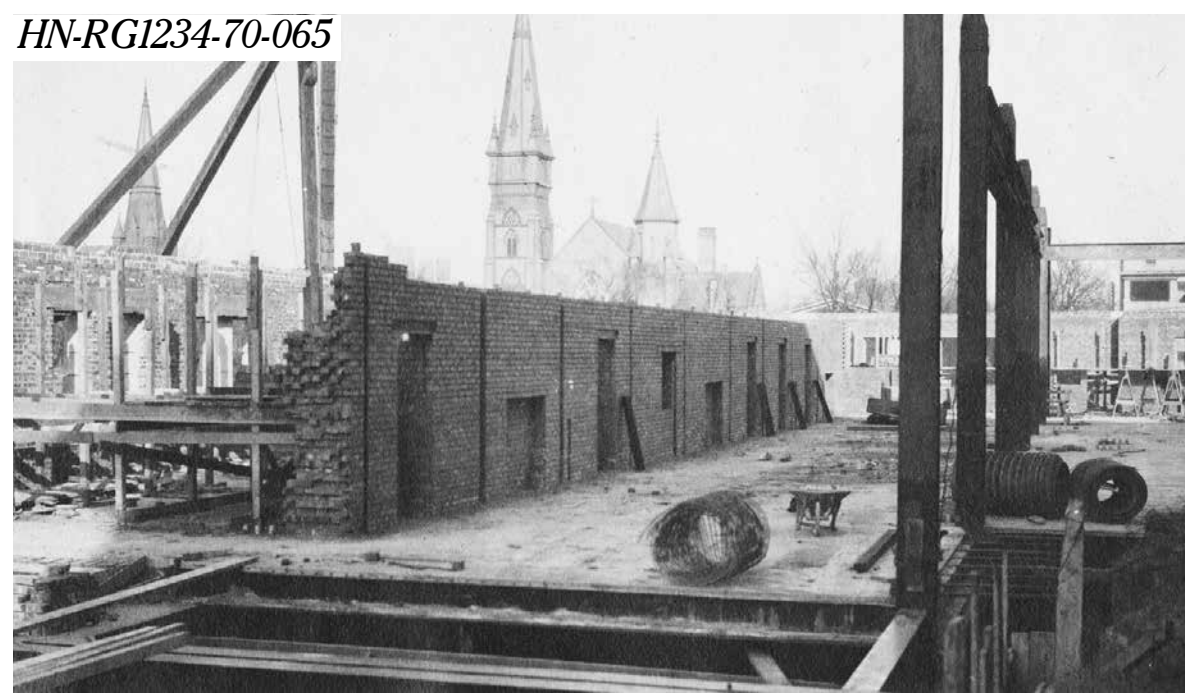
*A January 1923 interior view of the northwest corner shows structural walls of brick being laid atop piers and the structural walls hidden under the poured concrete first floor sub-floor. Steel beams provide additional support.*

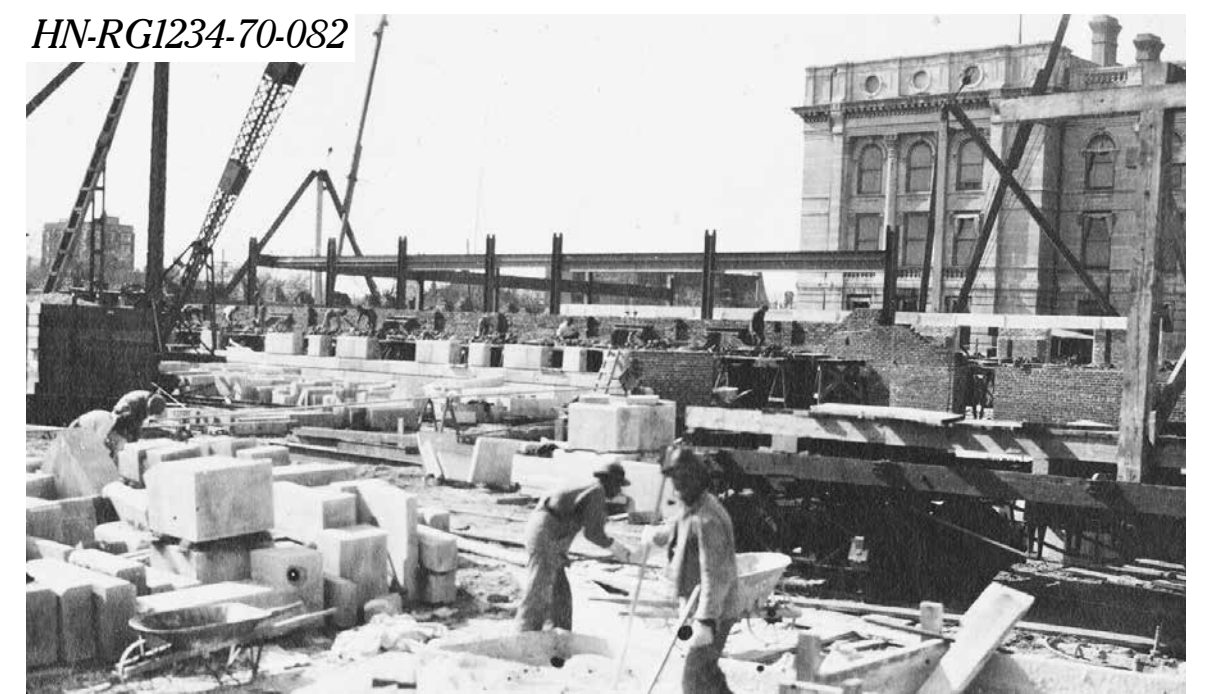
*By May of 1923 brick and limestone walls were rising on the south side of the 2nd Capitol. Construction activity took place on both sides of the tracks that circled the site.*

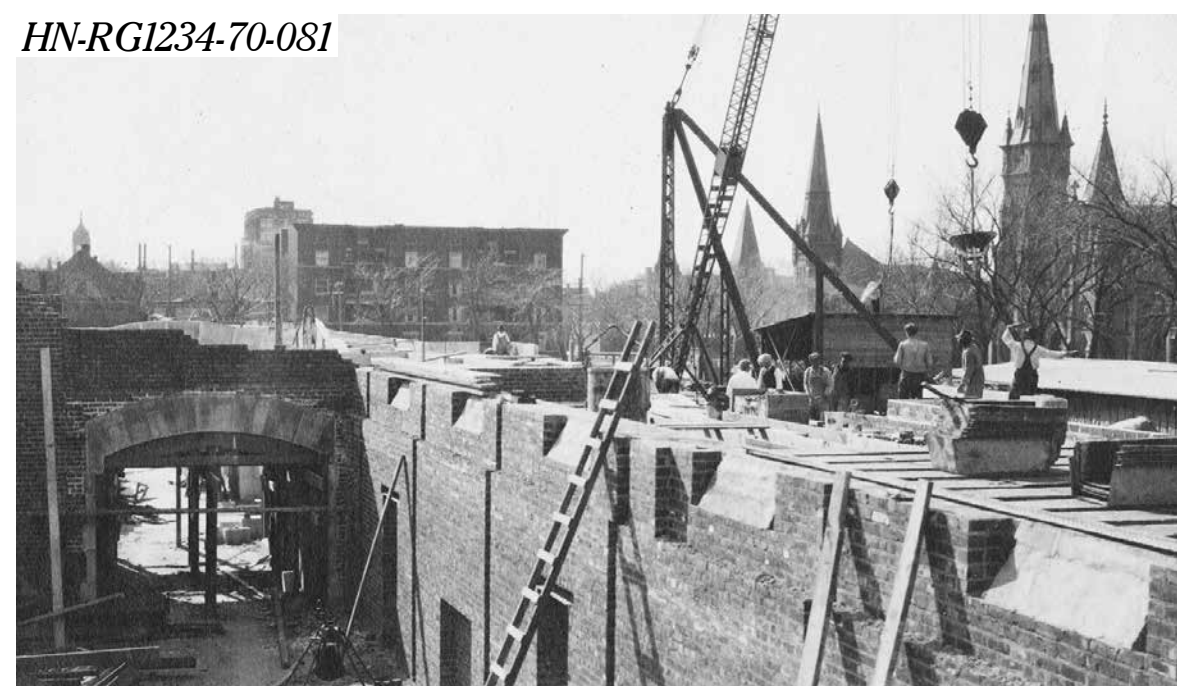
*The first floor north wall on the east side of the ground floor is in place by May 1923. The beveled openings of the ground floor clearstory windows provide a reference point in this view toward the north entrance vestibule.*

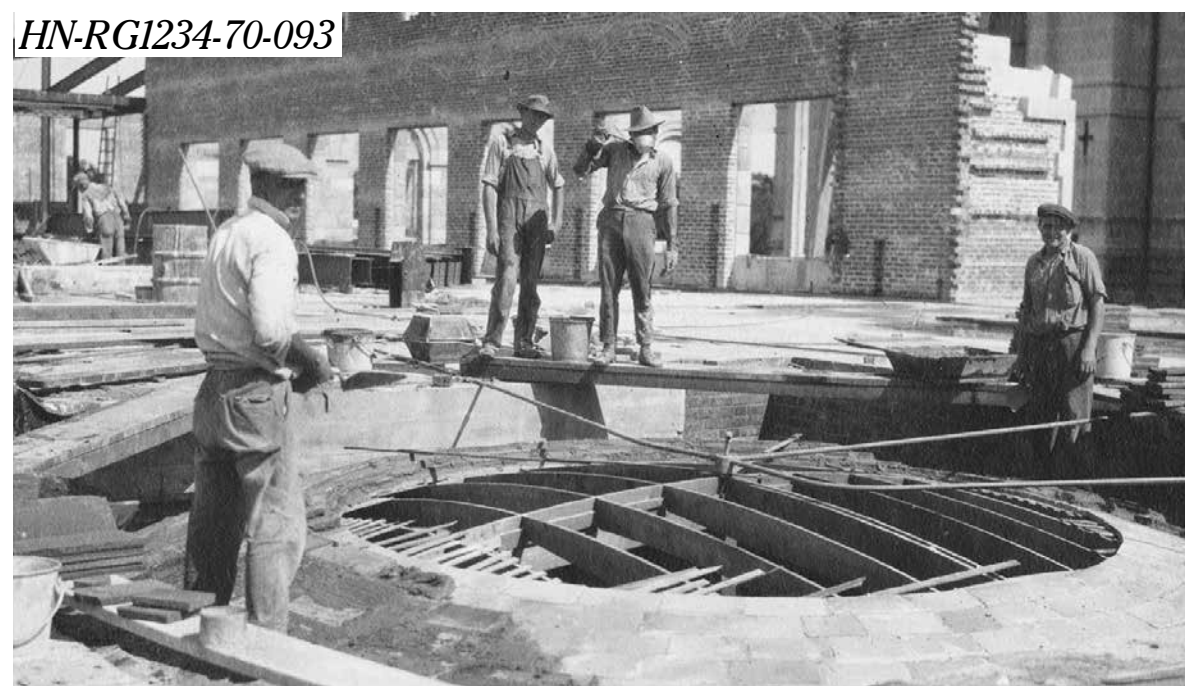
*In August 1923, a construction crew builds the Guastavino dome above the ground floor north entrance vestibule. Capitol architect Bertram Goodhue used Guastavino tile vaults throughout the building for structural support.*

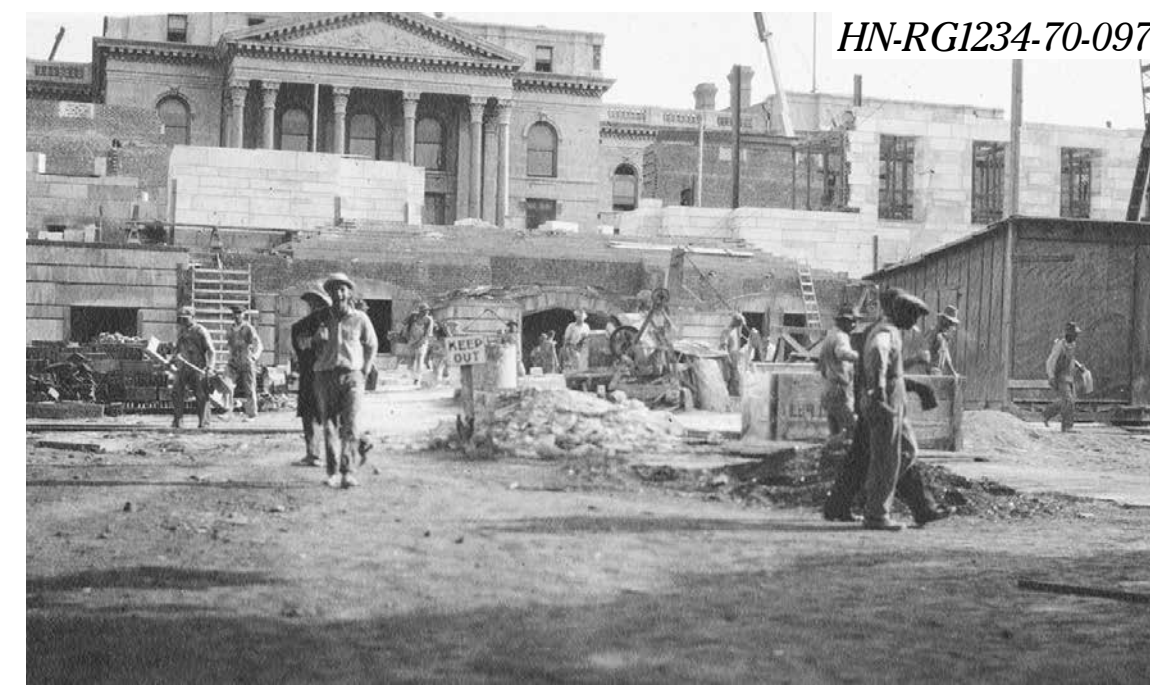
*This August 1923 photo shows the north entrance prior to the construction of the north plaza. Above the arches in the center of the photo, the upper stairs and the walls flanking the main entrance are visible.*

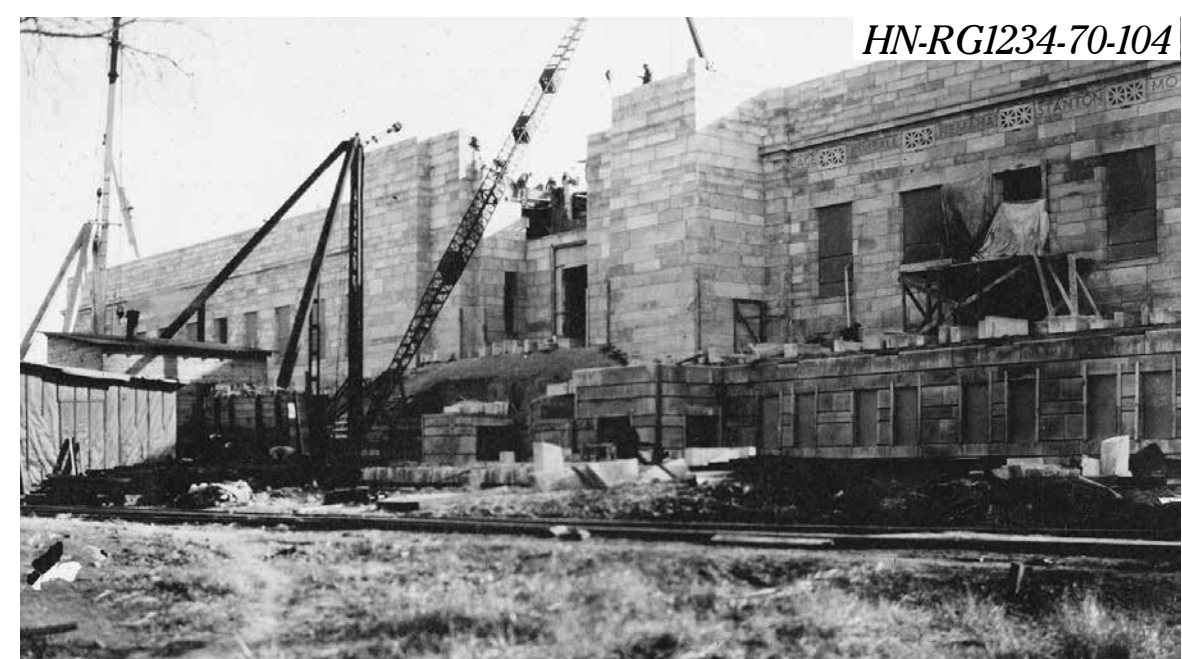
*This November 1923, photo of the north pavilion shows the north facade walls nearing completion. The main entrance portal barely rises above the opening for the north door.*

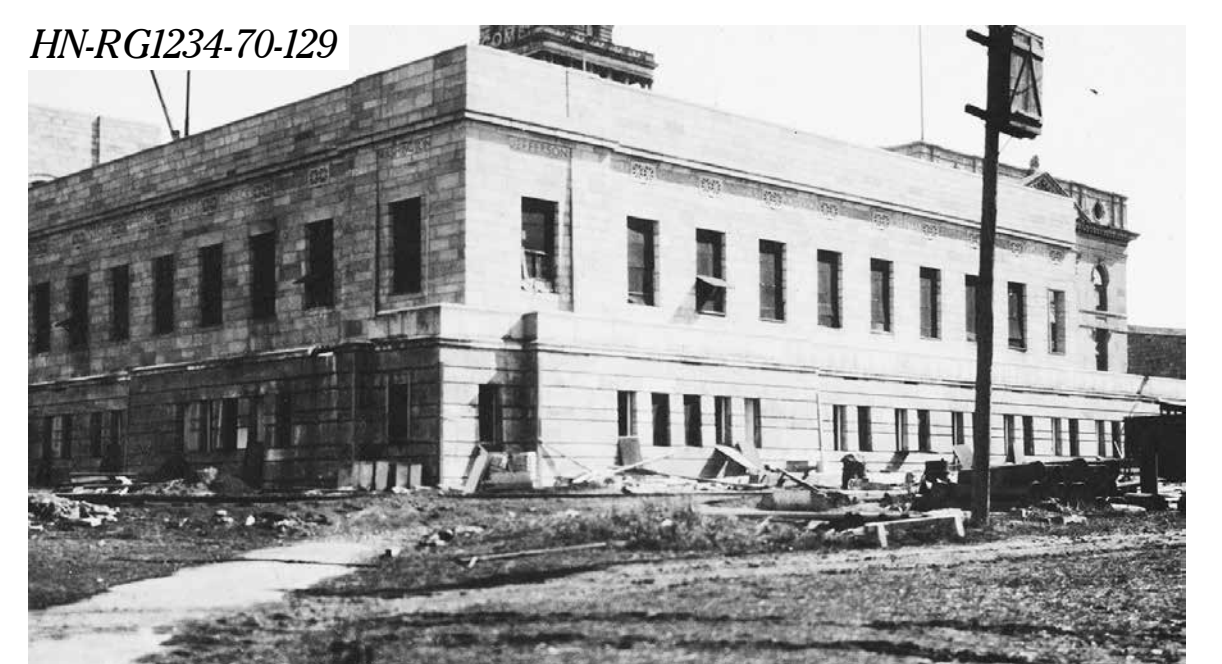
*This March 1924, view of the northwest corner of the new Capitol shows how the first phase of construction did not fully encircle the second Capitol, but was built to leave the east and west center sides open to allow for the eventual demolition and removal of the old Capitol.*
