100 years ago - No Going Back

After Capitol Architect Bertram Grosvenor Goodhue's untimely death in April of 1924, a reorganized Bertram Goodhue's Associates-- Francis L. S. Mayers, Hardie Phillip, and Oscar H. Murray-- entered into a new contract with the Nebraska Capitol Commission. On November 14, 1924, they agreed to finish the design and construction of the new, third, Capitol. Once again the project was moving forward and the Commission was busy with decisions about window finishes, linoleum floors and marble columns in the Governor's Suite. The intent of the Nebraska Capitol Commission was to have the first rooms in the new building occupied by January of 1925. Work to complete construction and furnish rooms continued through the spring of 1925. At their March 19, 1925, meeting the Nebraska Capitol Commission opened bids for the demolition of the second Capitol. The J. H. Wiese Company of Omaha received the demolition bid, the Commission later determined the State would retain the salvaged second Capitol marble and slate floor tile for use in the new building, ultimately used in the courtyards. With the first phase nearly completed and occupied, in late March of 1925, the C

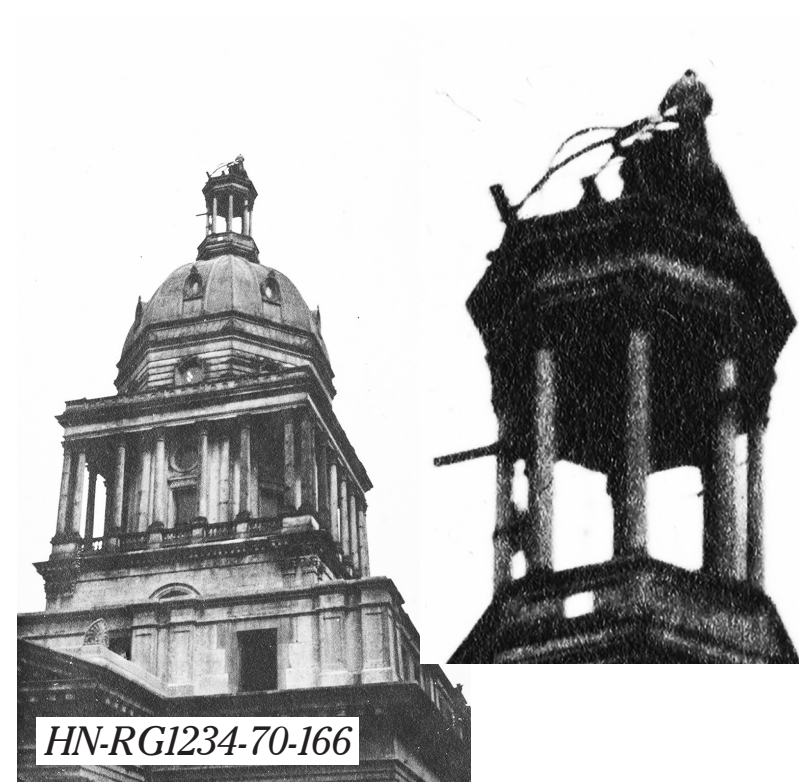
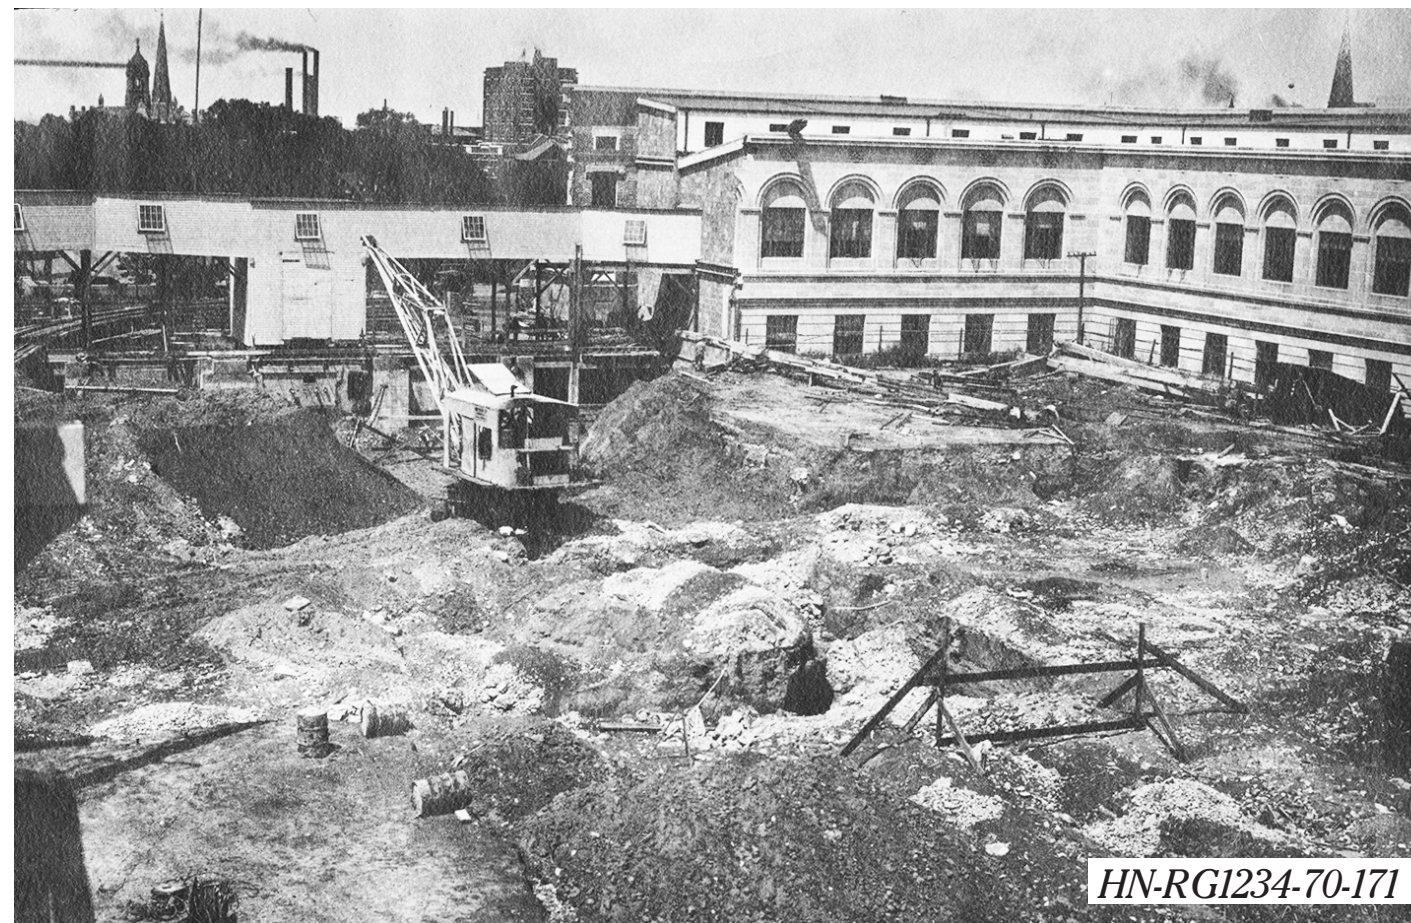
HN-RG1234-70-166

Left, seen from the Lincoln Monument, the second Capitol is enclosed by the outer square of the new building, an enclosed elevated walkway leads between the north and south sections of the new building. This west side of the square would be the last section completed in 1932. Above and inset, June 1, 1925, demolition workers remove the cupola from the second Capitol.

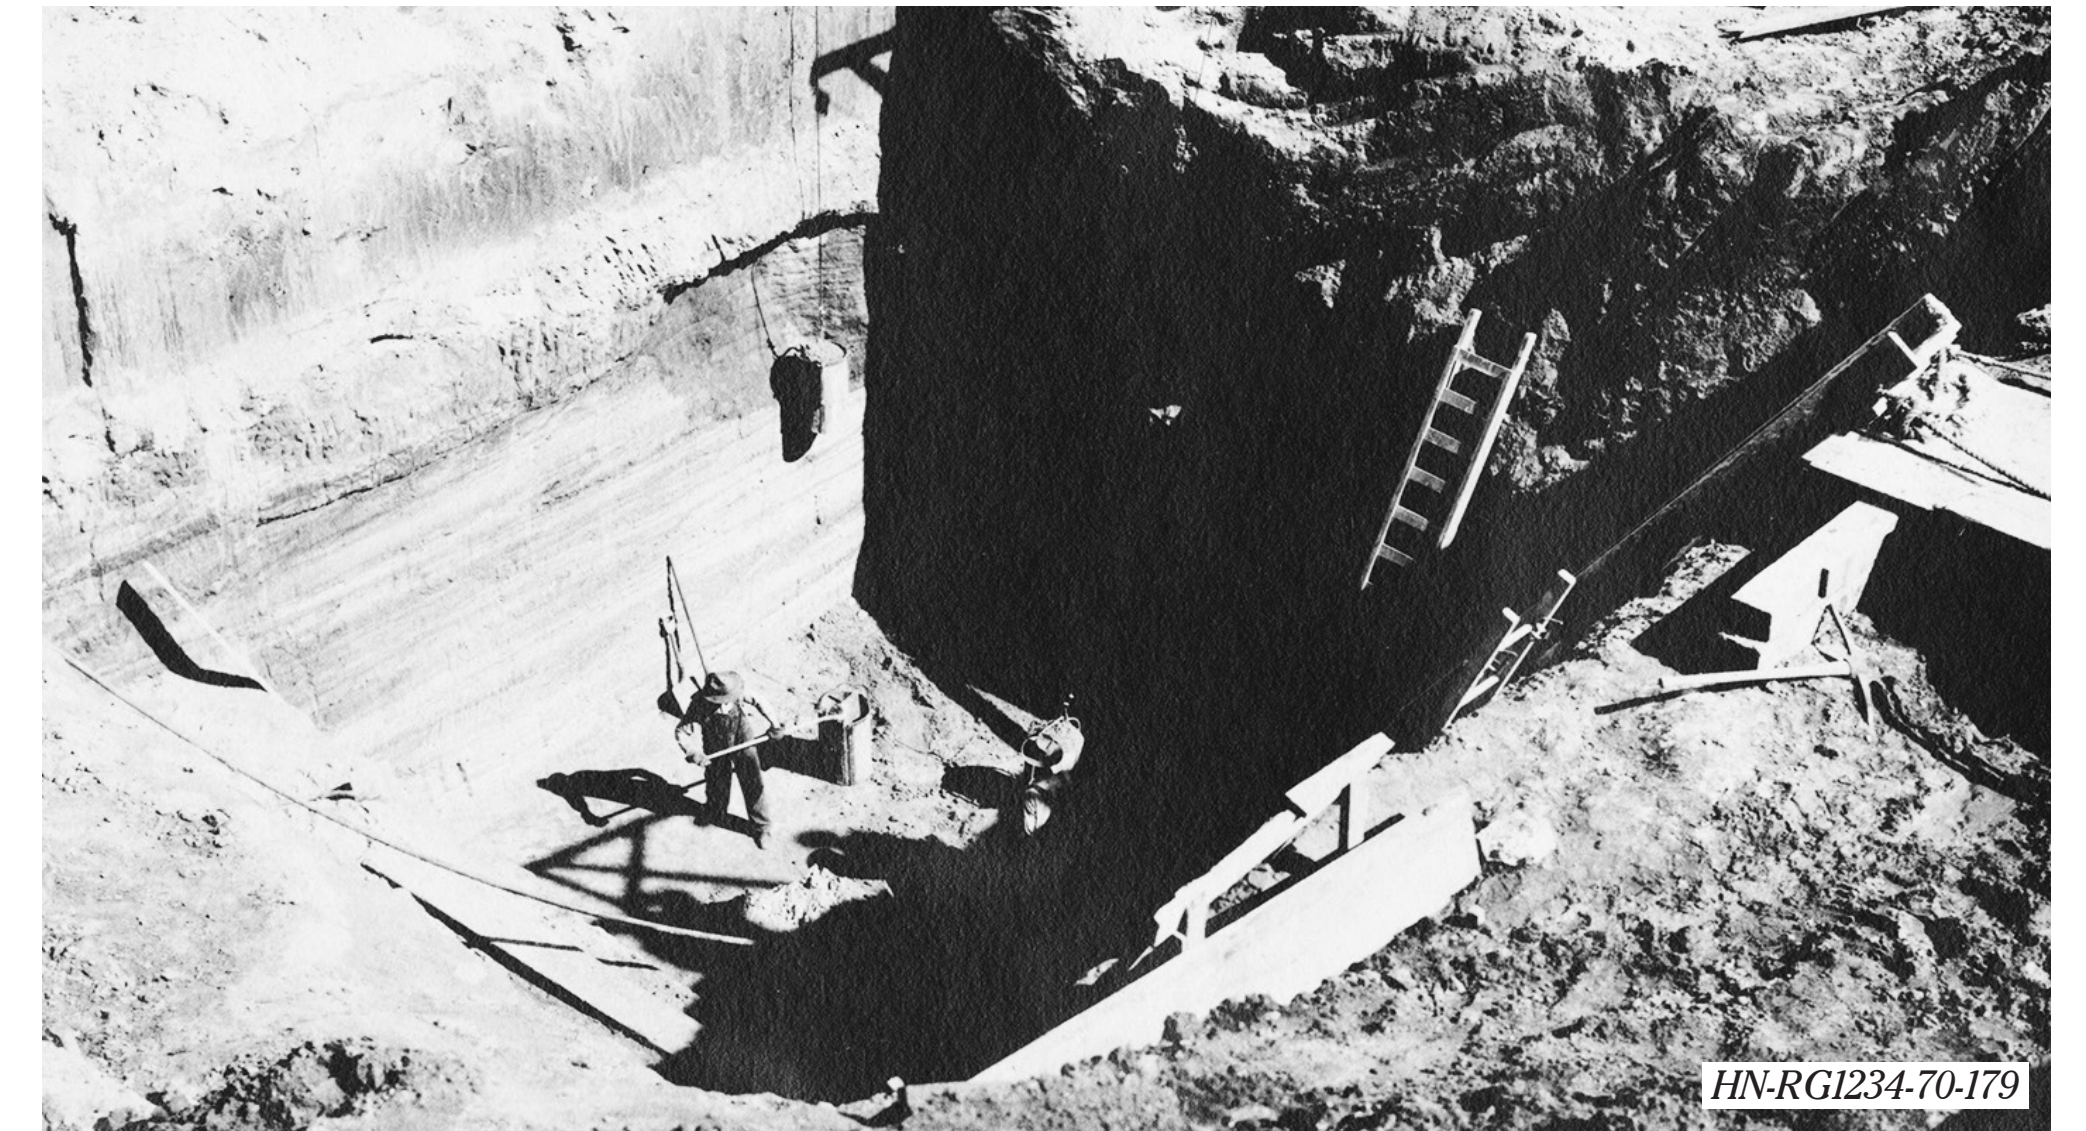
HN-RG1234-70-179

By August 1, 1925, all that remains of the second Capitol is scattered rubble. Excavation of the footings, foundation and basement will be done from within the outer square. A rail line will be brought into the center under the east and west walkways. Excavation cranes will place the removed soil into railcars to be carried away and used for fill at the State Fair, now Innovation Campus, site along Salt Creek.

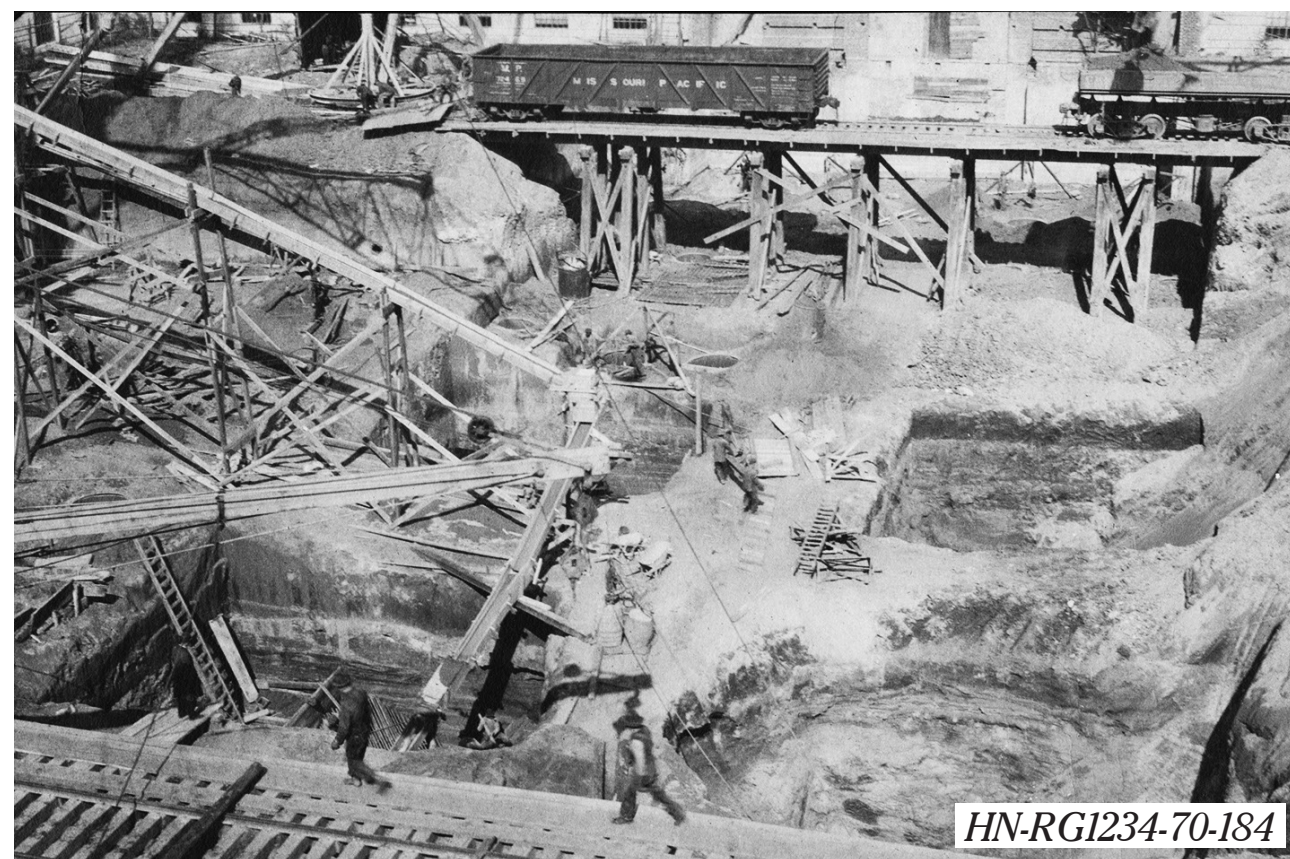
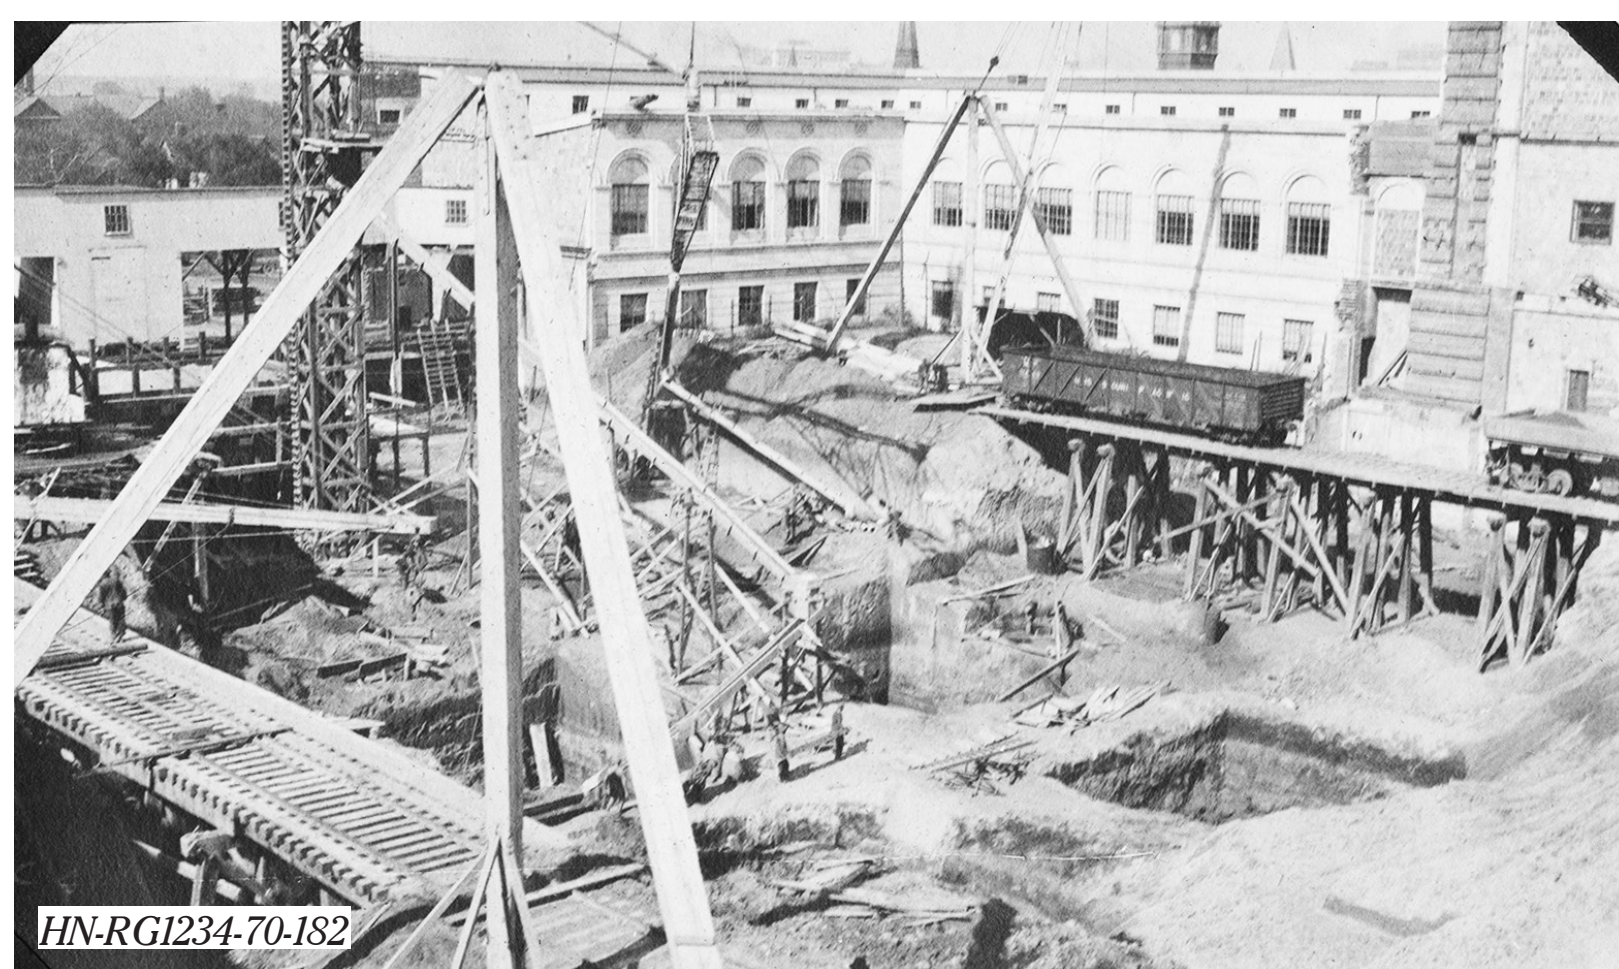
To facilitate the excavation and removal of the soil upon which the second capitol stood, the rail line had to be extended and by October 10, 1925, entered the center of the site from the east and west sides. Excavating the basement of the third capitol down to the level of the newly completed outer square's basement filled railcar after railcar. In the above left photo, the rail line enters under the enclosed walkway which allowed movement between the north and south outer sections of the third Capitol. An excavator is parked on the rail line removing soil from what will become the first floor corridor under the East Legislative Chamber. Rail cars on either side will carry the soil away.

In the above right photo, the tower pier holes are being excavated. The pier in the hole on the left has been formed in the bottom and concrete will flow into the form through a series of channeled chutes coming from a concrete lift tower seen in the photo on the left. The photo below shows the same scene but looking to the north rather than west. In the right side of the photo below the rail line passes over the excavated first floor north corridor in front of the bricked-in arch between the Vestibule and the not yet constructed Foyer.

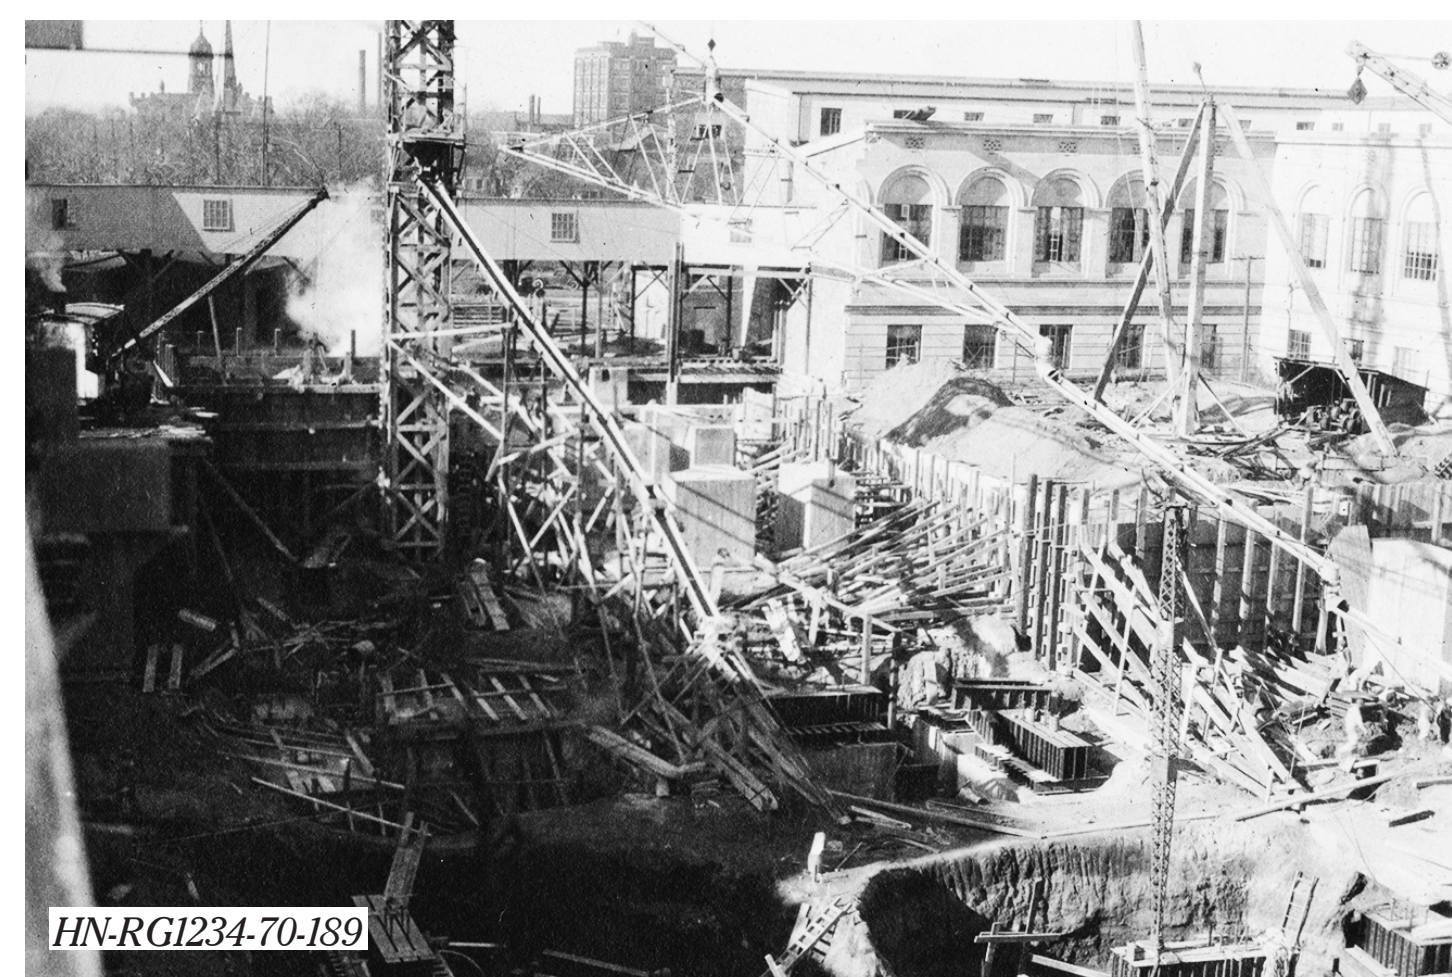
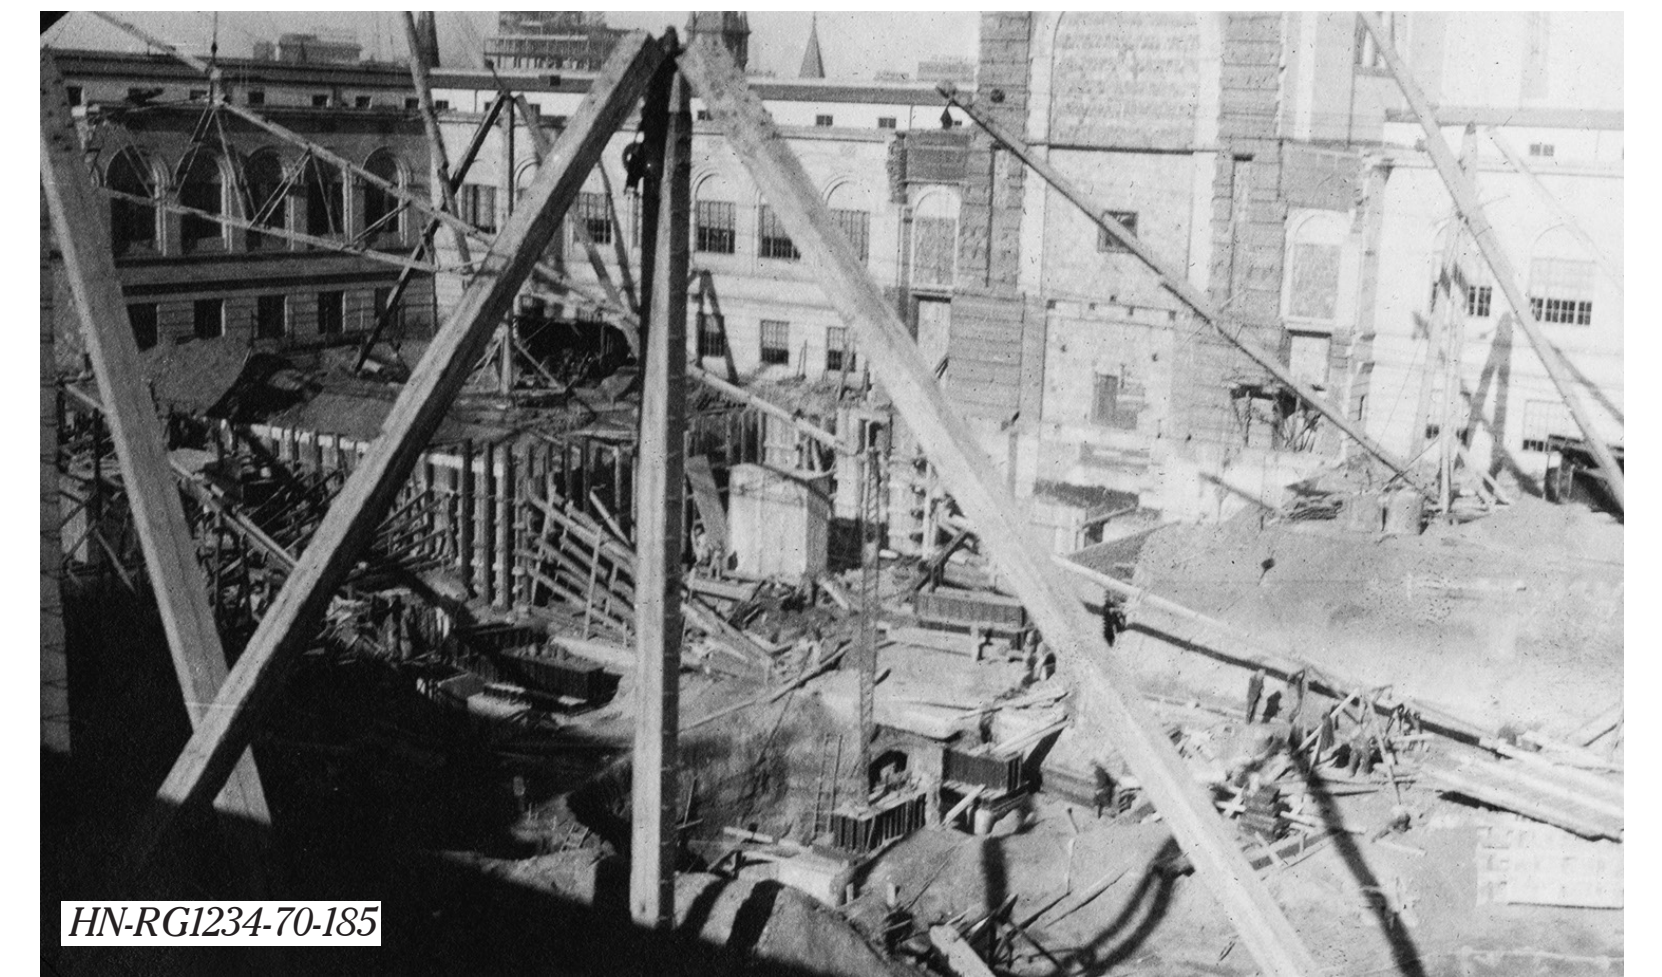
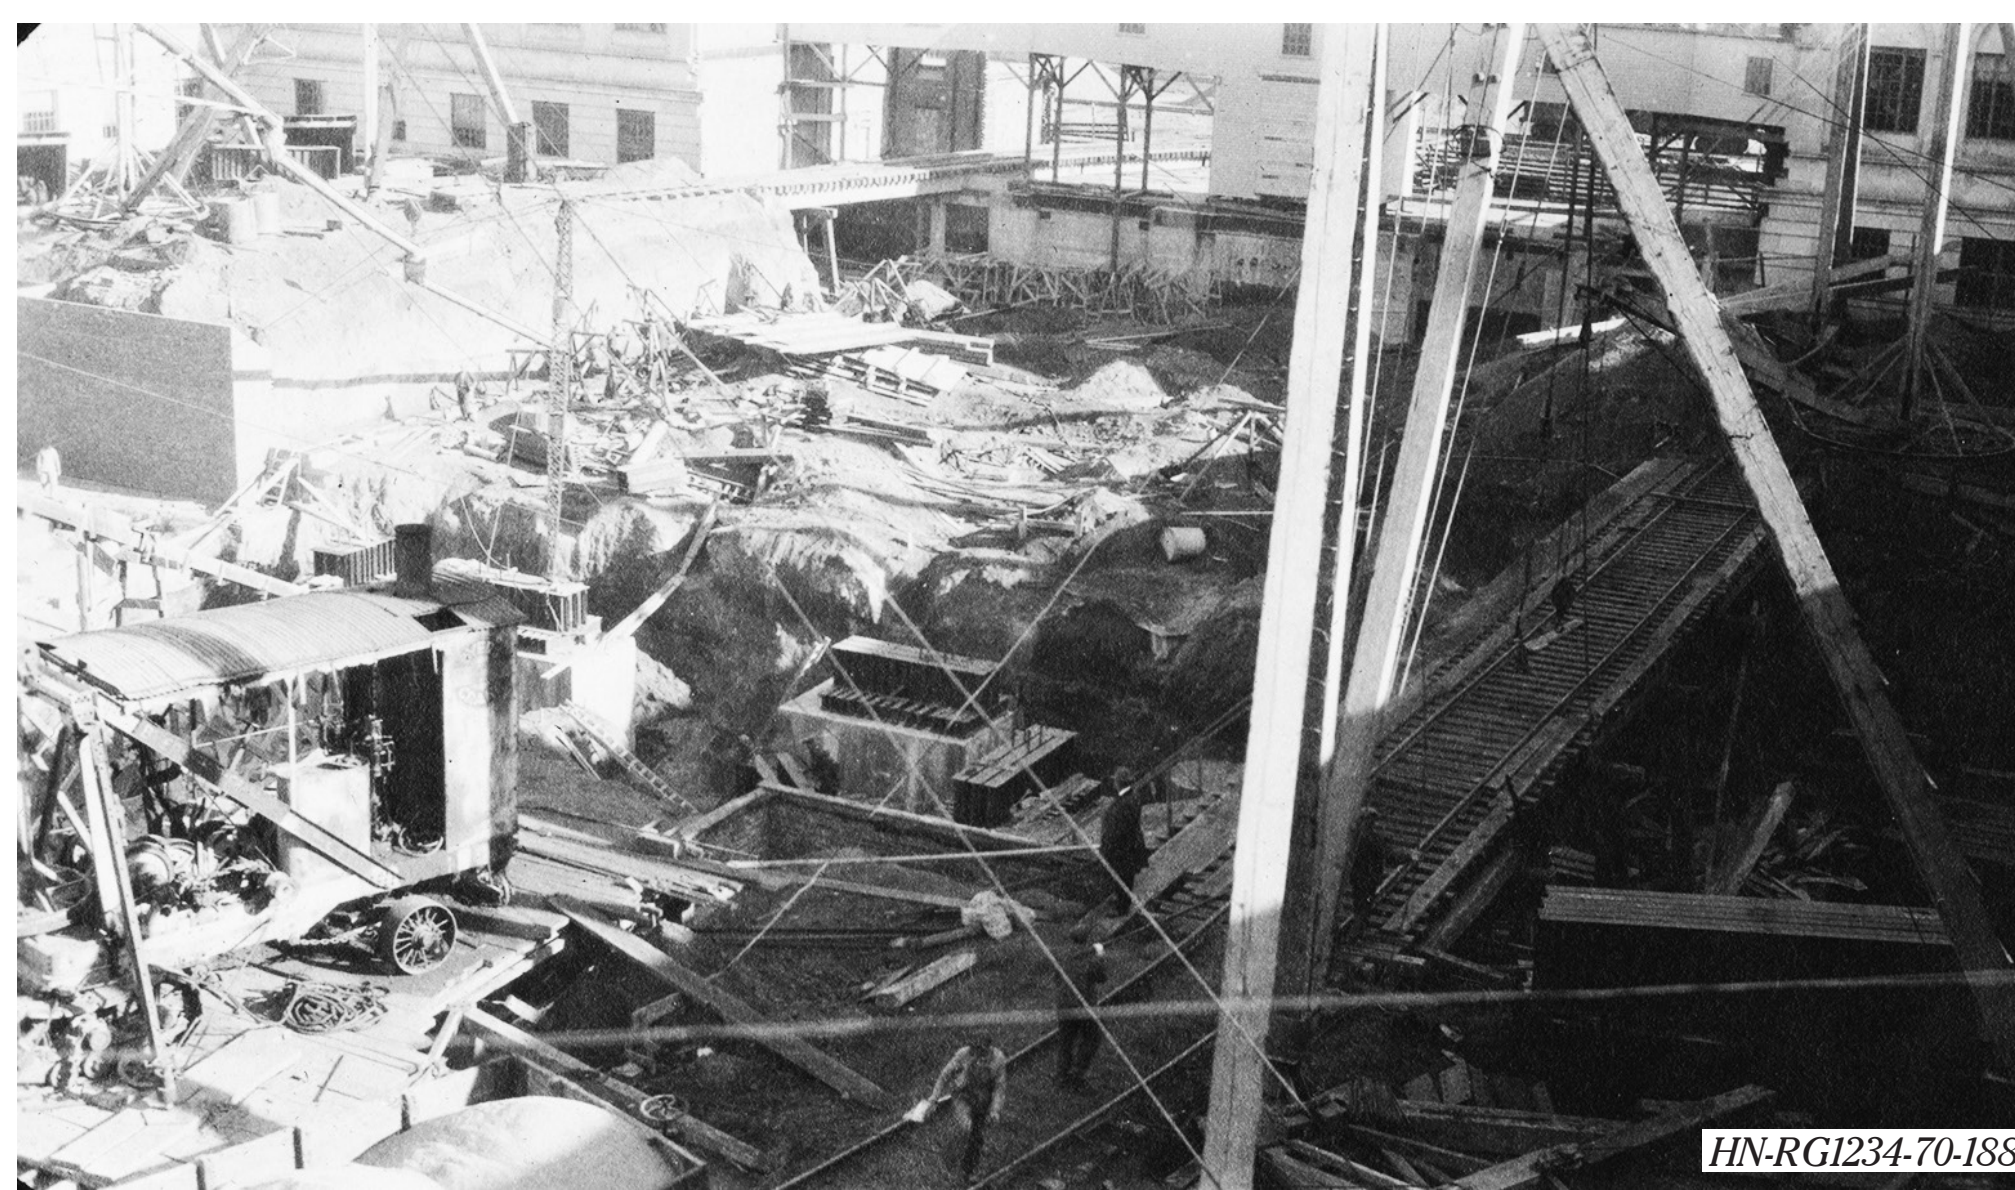
By December of 1925 the scene inside the outer square of the new capitol had changed, excavation of basement and foundation walls was progressing. The rail line entering from the east had been removed to facilitate the architects plan to close the east side of the square base and build into the center. In the above photos, left looking west from center, and right looking north, the rail line is gone and the interior basement walls enclosing the courtyards are being defined; concrete work continues on the tower piers.

In the photo, below left, the east section of the basement is almost completely excavated. The concrete piers of the tower are visible in the middle of the photo. The arched windows in the photo on the right are offices in the new building and house state employees who, just like in the second Capitol, conducted state's business in a construction zone. In this north looking view piers which will bear the weight of the tower are visible in the foreground.
